SPE (Society of Petroleum Engineers) Workstrings International

SUBJECT: RUST GRIP®

Drill string piping AND Intervention Riser Tubulars

No Pipe Body Downgrades - Improved Corrosion Mitigation Coating System Provides Significant Operator Savings

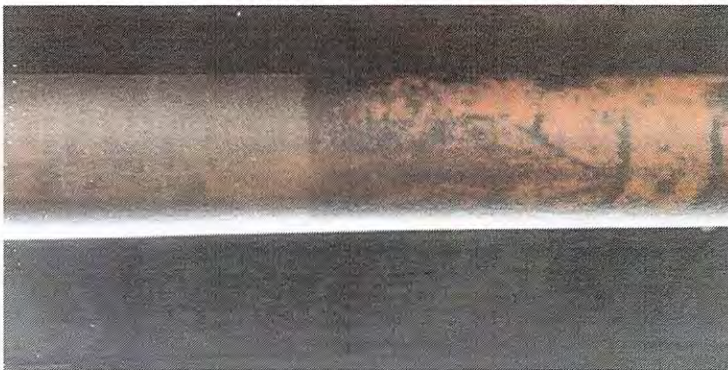
Rust Grip® vs. **Uncoated**

Pipe shown above returned from a completion well project

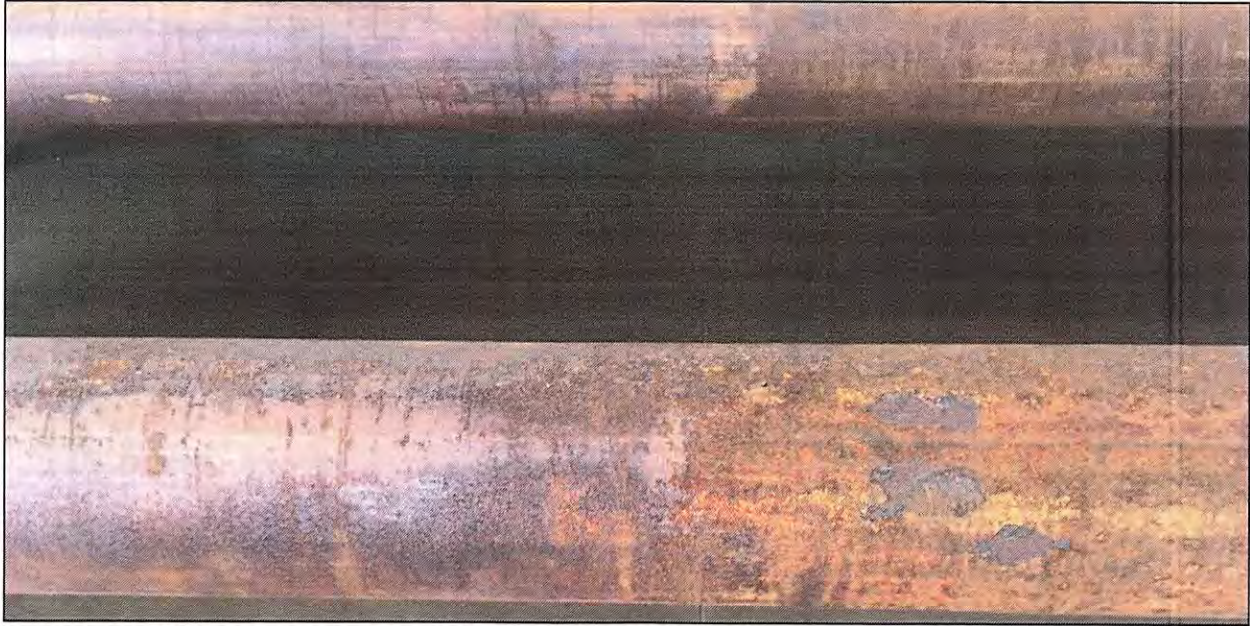
Operator 2015 Completion Trial 1 – Tried 3 potential products in the field for approximately **114 days**, exposed to **10.8ppg to 11.35ppg** CaBr₂ for **37** of those days. Joints coated with Product E were the only trial joints visibly recognizable on the return.

Left side of completion pipe coated with external coating /Right side uncoated, before blasting

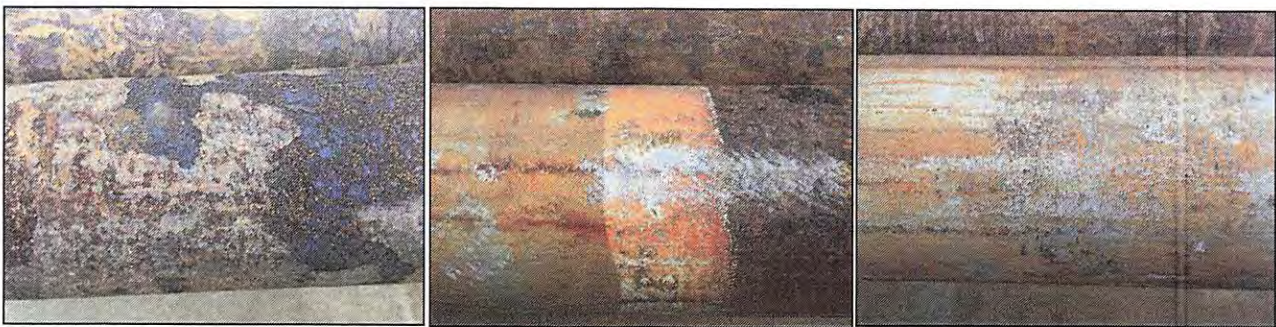
Operator 2015 Completion Trial 2 – Tried 2 products in the field for approximately **145 days**, exposed to **14.3ppg to 14.4ppg** CaBr₂/ZnBr for **119 days**. Joints coated with Product E were highly recognizable on the return.

Completion pipe transition from uncoated to coated side, before blasting

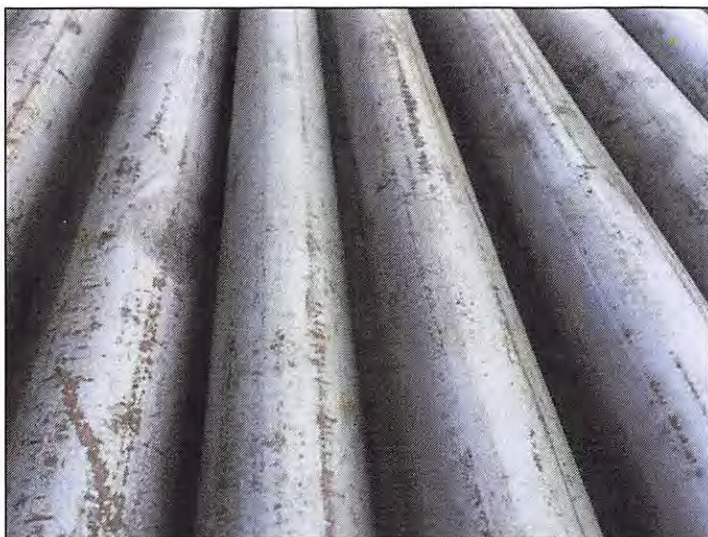
- Coated 6 5/8" LS with Product E Results
 - March 2015 - #1 – Coated 6 joints - 55 days in service - 0 downgrades
 - May 2015 - #2 – Coated 64 joints - 31 days in service - 0 downgrades
 - July 2015 - #3 – Coated 74 joints - 24 days in service – 0 downgrades
 - August 2015 - #4 – Coated 44 joints - On-going at the time of this report
 - Sept 2015 - #5 – Coated 86 joints - 19 days in service - 0 downgrades

GTM69, as returned from open water P&A, before blasting

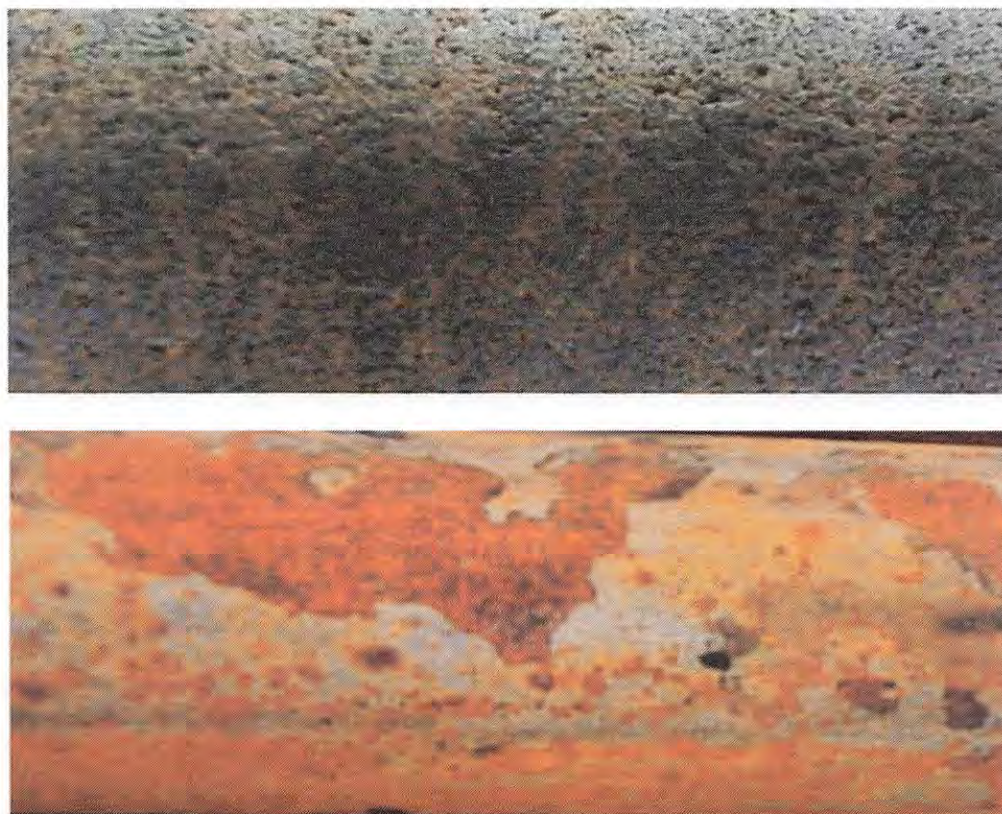
Completion and intervention riser tubulars are exposed to both the marine environment and to corrosive oilfield chemicals, including salt-based completion brines. Eight years of field history from Gulf of Mexico deepwater projects for one pipe rental company showed a loss of \$17.5 million from pipe body downgrades due to the corrosion and pitting of completion tubulars and a loss of \$6.8 million from pipe body downgrades of intervention risers. See Figure 1. These 30,000 ft. well depth projects magnified the corrosion problem and costs. Typically, operators require that these tubulars have a minimum of 90 to 95 percent of the nominal pipe body wall thickness for offshore use. Corrosion or pitting that removes wall thickness below these limits will result in the tubular being no longer fit for service. Severe pitting can cause the asset to be uninspectable with current tubular inspection equipment and technology due to the roughness of the surface and, therefore, the asset must be removed from service.

Figure 1—Examples of pipe body corrosion and pitting.

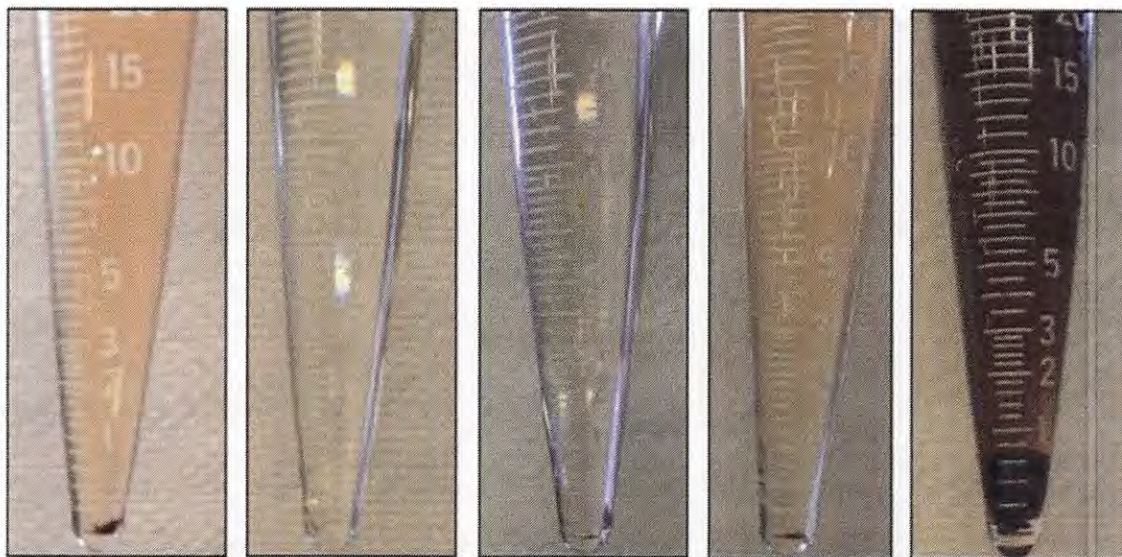
The four selected products then underwent a test in completion fluid to monitor the iron-oxide solids produced after an extended time exposed to completion fluid. All four pipe samples with each a different coating product produced very few solids compared to the uncoated pipe sample with a 75-100% reduction in solids compared to the uncoated sample. This testing was done to have a general understanding of the relative difference of a coated surface to an uncoated surface in completion fluid. The measurements were not as important as the scale of difference. The fluids from the coated samples were clear to slightly tinted where the uncoated sample fluid was visibly red/dark due to the iron oxide products, see Figure 3.

Figure 3—Four coating samples tested on pipe samples immersed in 14.2 ppg CaBr₂ fluid for 12 days against uncoated pipe sample on the right.

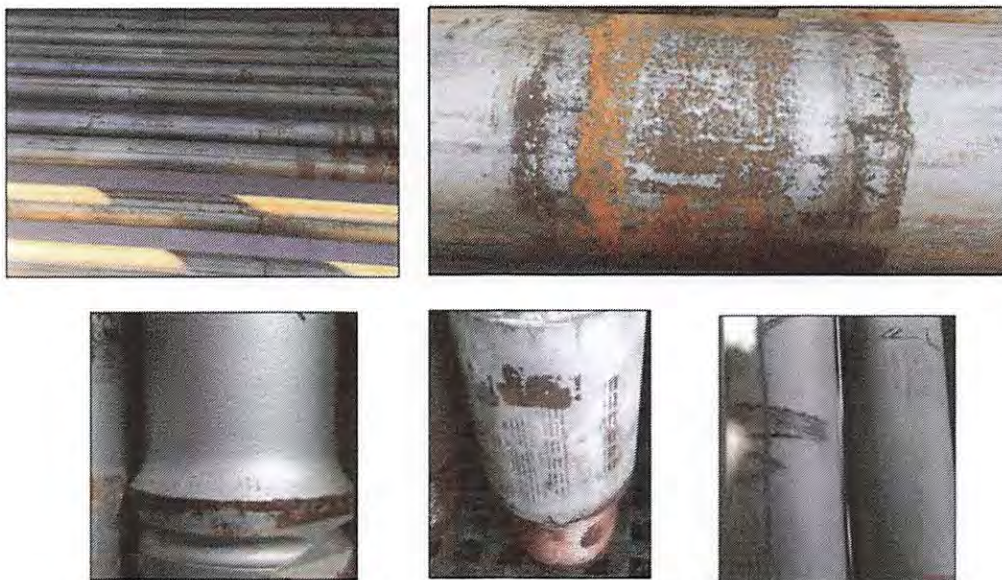
The coating appeared to withstand the rig environment with no observed flaking or peeling. The coating was removed on some regions of the tool joints mainly where the iron roughneck spinners contacted the pipe body. See Figure 6.

Figure 6—Some damage to coating from spinner, pipe handling, and tongs.

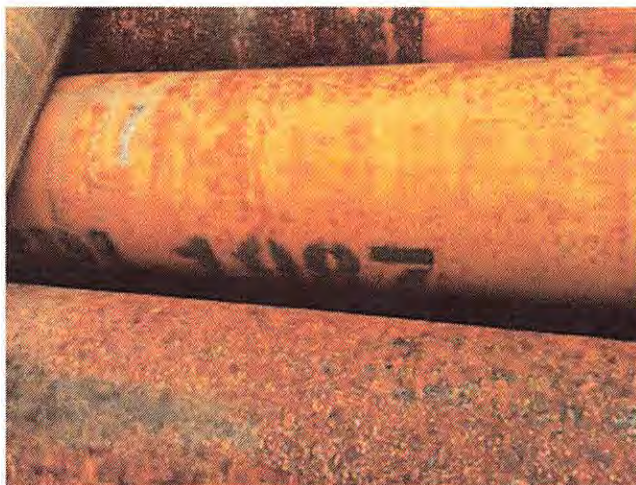
A visual inspection of the returned joints was conducted. The external coating was still intact, protecting the pipe from excessive corrosion. The uncoated joints had significant rust and scale build up. See Figures 7 and 8.

Figure 7—Coated joint (top) and uncoated joint (bottom) post-completion.

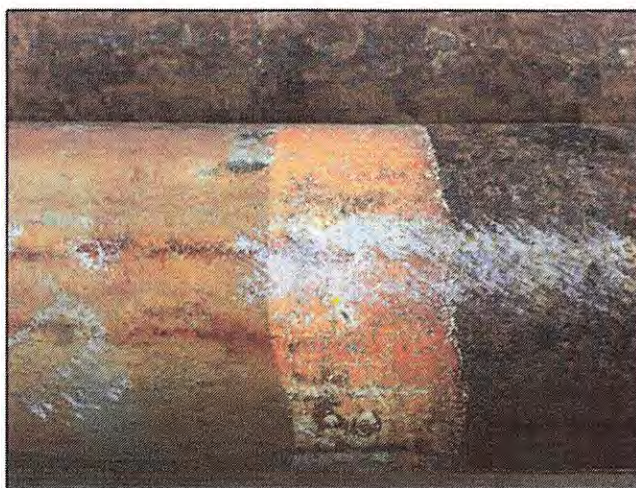
Figure 8—Close-up of coated pipe 1/2 joint (left) and uncoated pipe 1/2 joint (right).

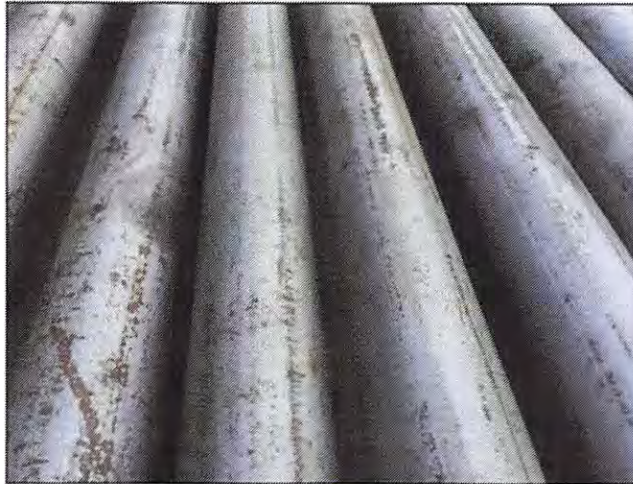
In 2015, open water intervention projects were becoming more frequent and the first uncoated intervention risers were damaged by extensive pitting that required the operator to purchase the pipe. Several open water fields trials were conducted to evaluate the selected coating system, EC8, under intervention riser application conditions. See Figure 9. These are summarized in Table 4 below.

Figure 9—Pipe as returned from open water trial.
