HAMMER SHAFT PROTECTION

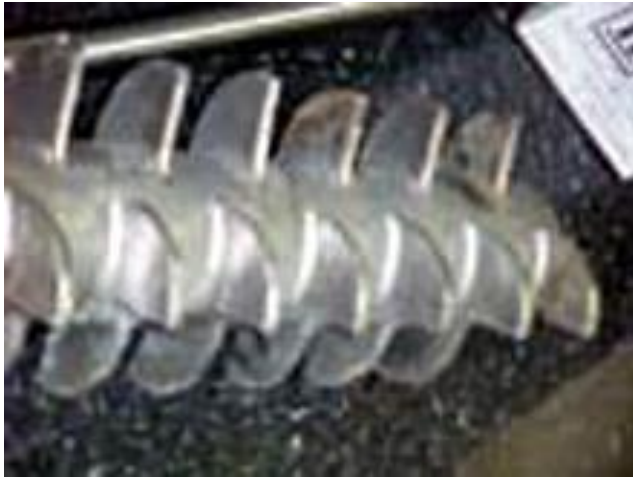
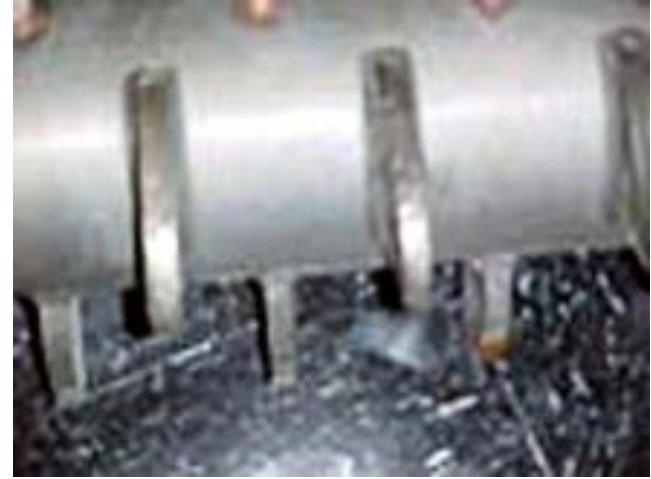
This is a hammer shaft removed from a fertilizer lump crusher. It was coated with **RUSTGRIP**® and installed two (2) years ago. The crusher runs approximately six (6) days per week, sixteen (16) hours per day.

Normally due to abrasion caused by the fertilizer the ears on the shaft are worked to the point of replacement within one (1) year. Now after two (2) years it shows no wear and will be reinstalled in unit. Unit went down because of a broken shaft.

The only explanation we could come up with that prolonged the life of the unit was the coat of **RUSTGRIP**®.
