Insulation Project for Thermal Power Plant

This new project is the thermal insulation of the big pipe that collect the exhaust gases from the turbines and carry them to the chimney.

The pipe has a diameter of 4 to 5 meters and a length of 117 meters.

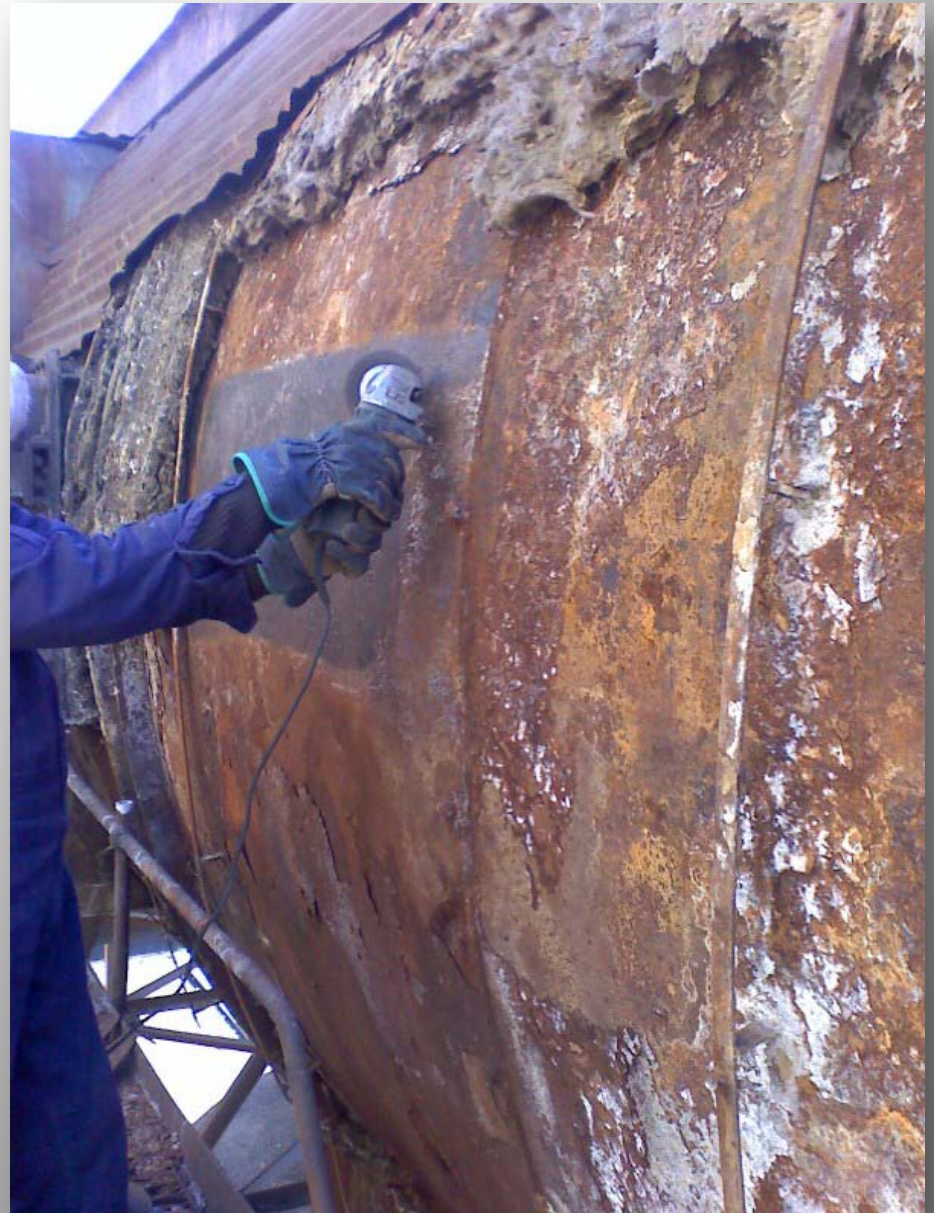
Surface condition before
and after power tool
cleaning

1. Power tool cleaning
2. Hand wash with clean water and a brush. (Pressure wash with Chlor*Rid will be used in case of performing the work)

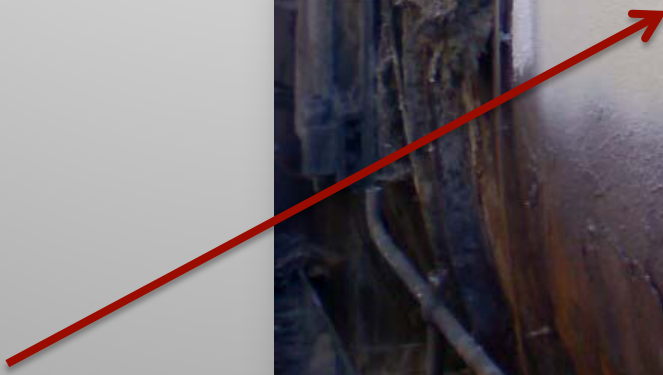
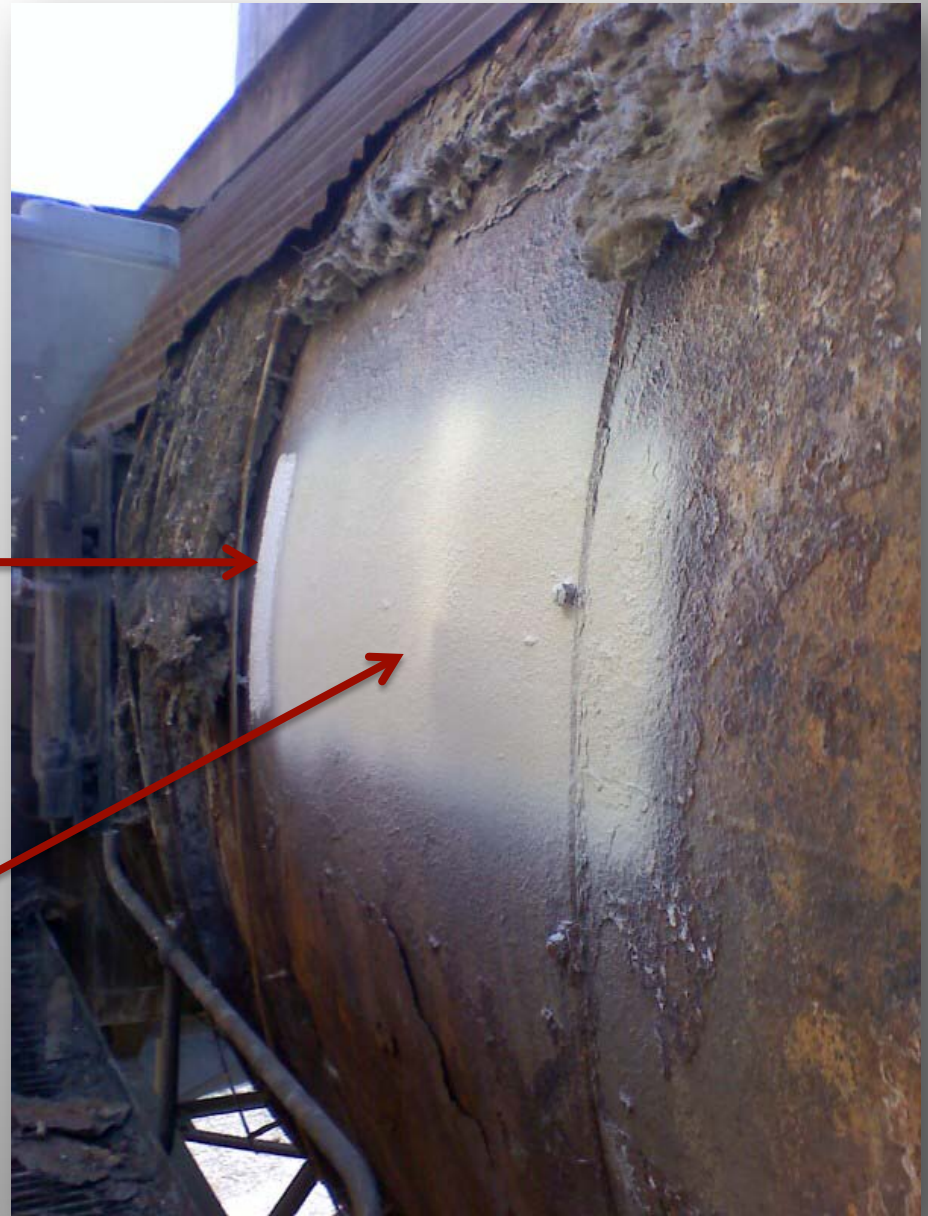
Then we began to apply
Hot Pipe Coating and Hot
Surface Coating 300

HSC300

HPC

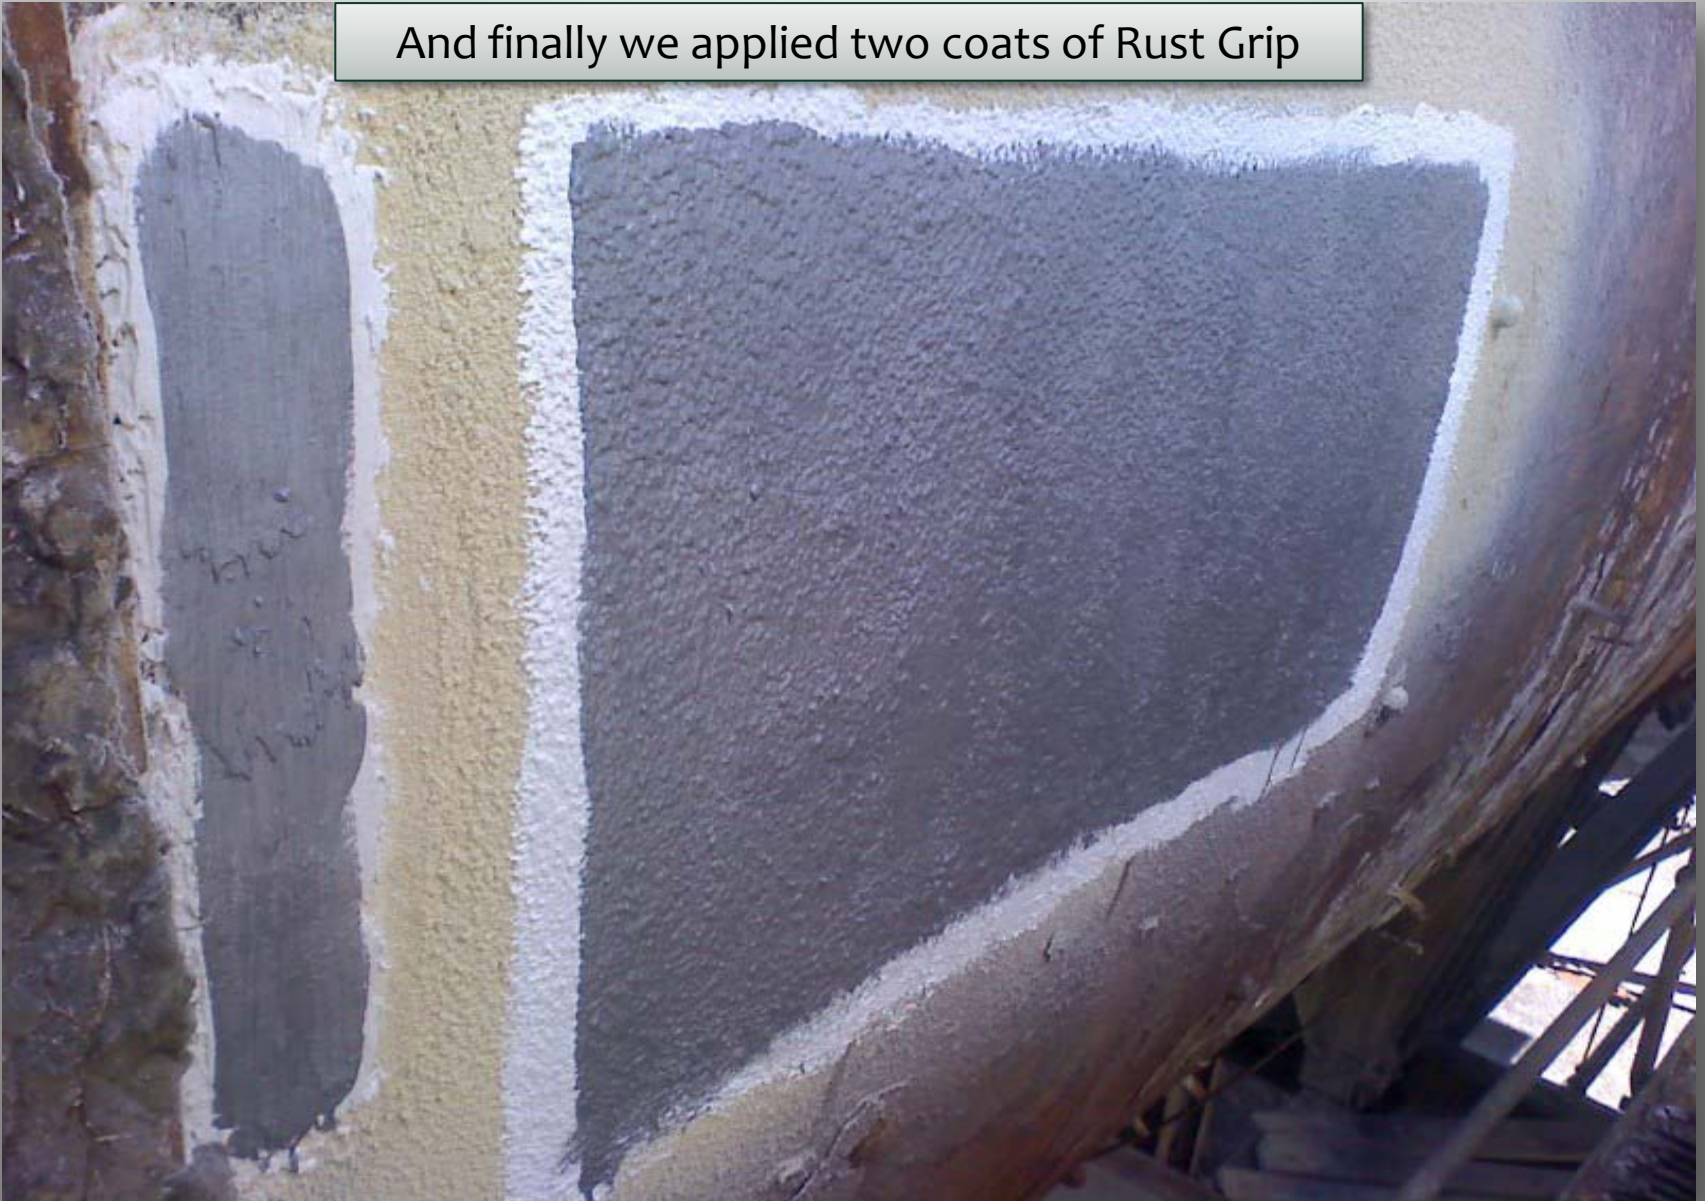
The next day we applied two coats of Super Therm on top of Hot Pipe Coating

Hot Surface Coating 300

And finally we applied two coats of Rust Grip

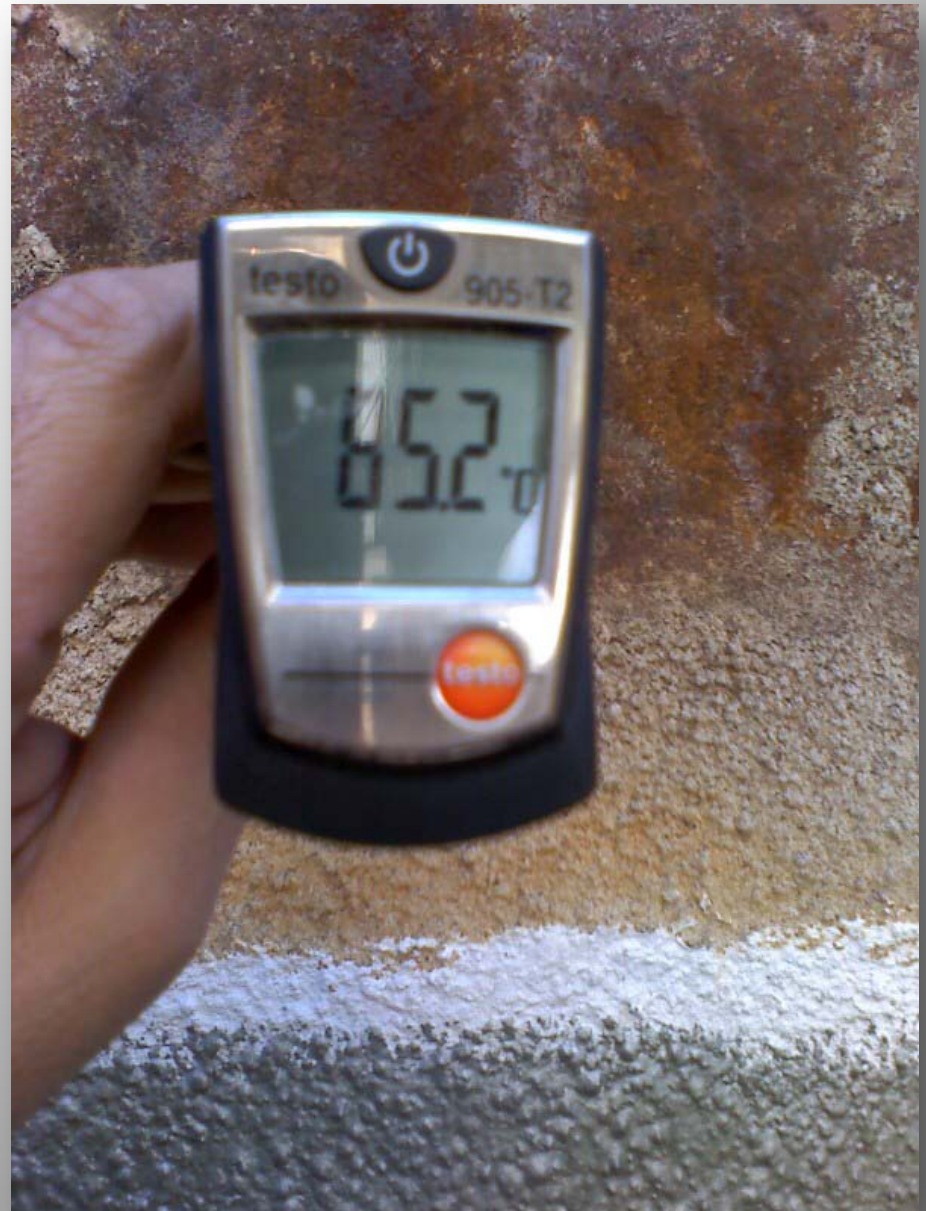
We took the temperature on the outside pipe surface: It was around 85°C

We came back two weeks later to measure
DFT and temperatures.

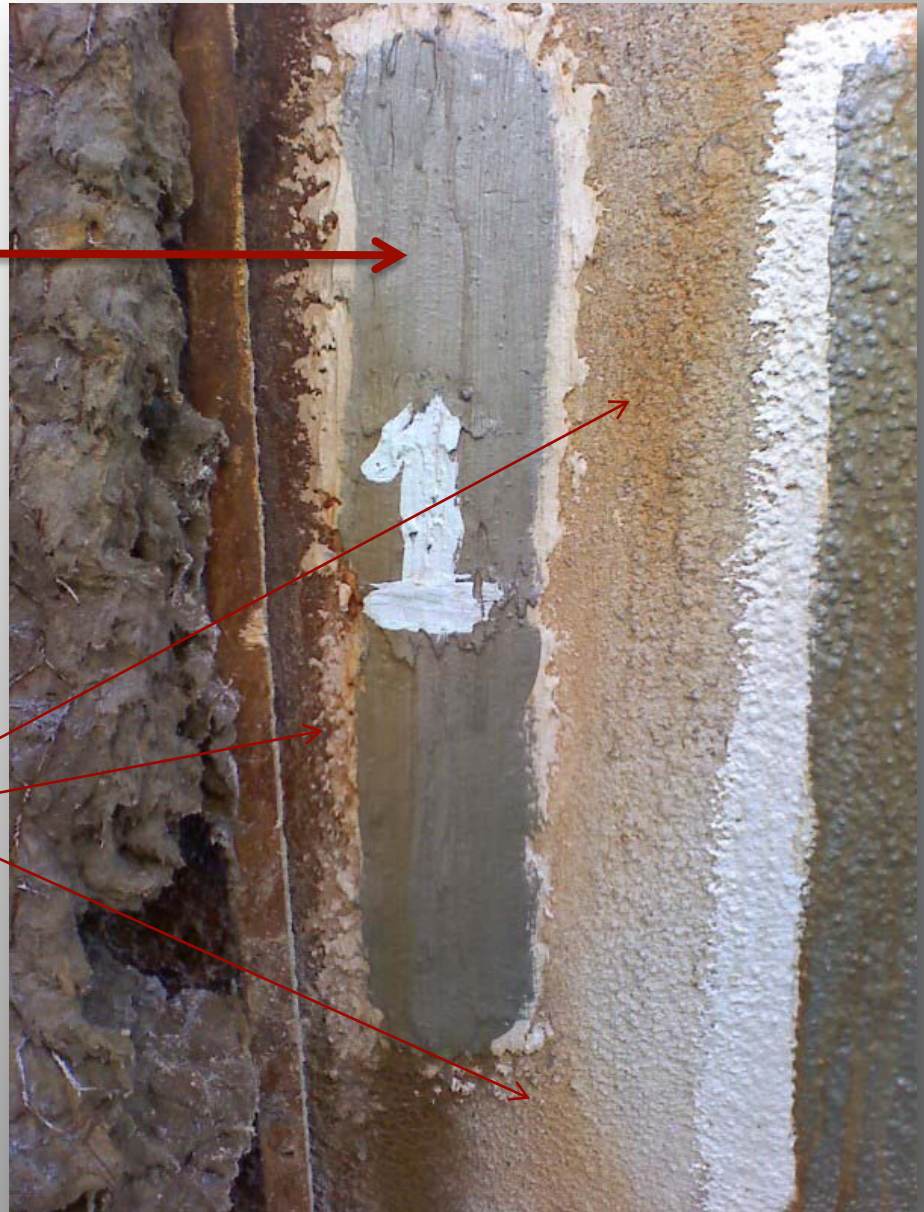
HSC300 +
Rust Grip

The brownish color was caused by
water dripping coming from the
upper corroded area

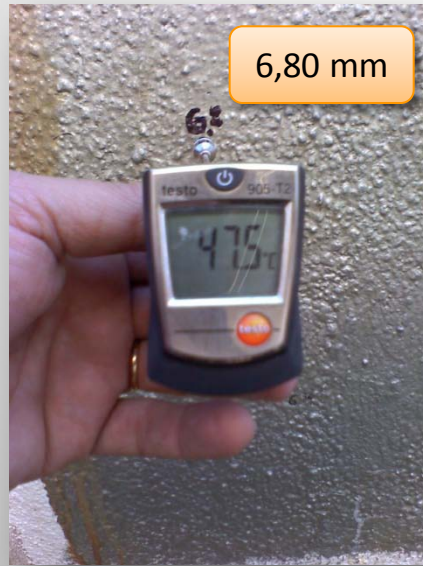
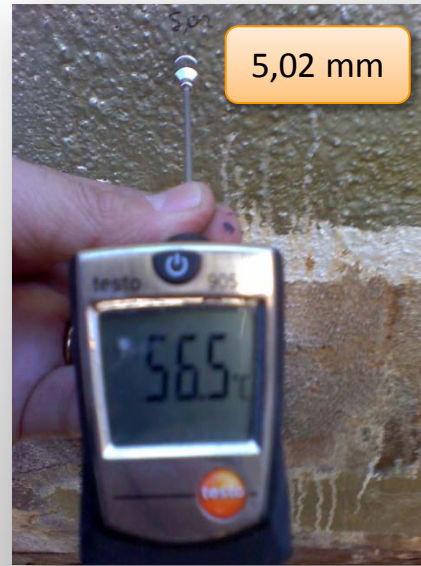
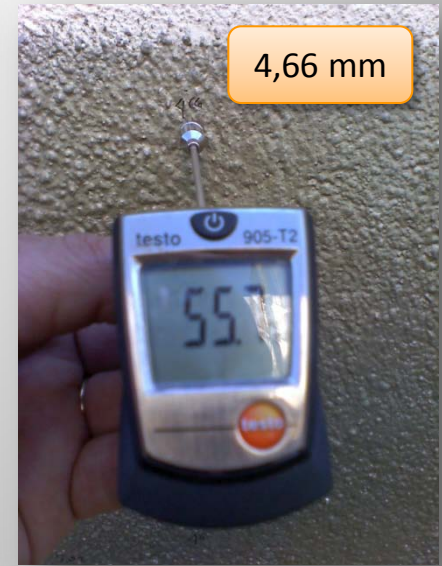
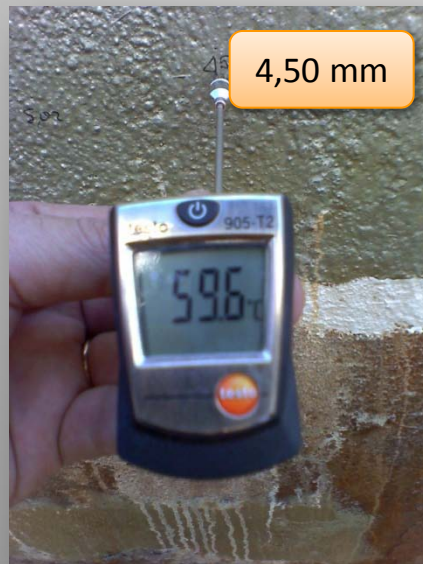
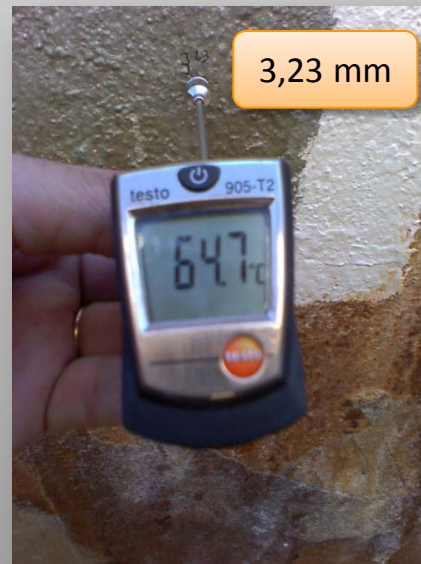
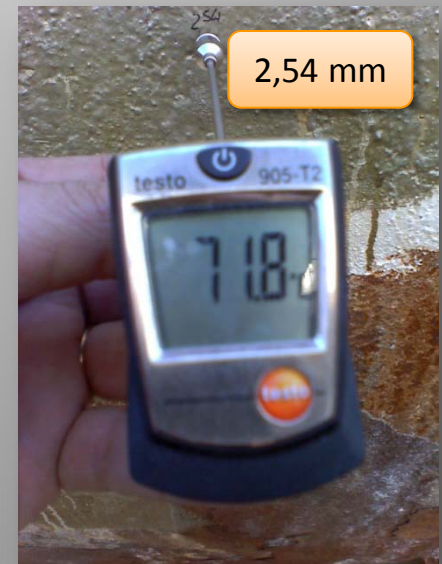
HPC

We have noticed a significant temperature difference between both materials with thicknesses nearly equal. We assume that this difference arises from the middle layer of Super Therm. From the customer point of view, the lower the outside surface temperature, the better.

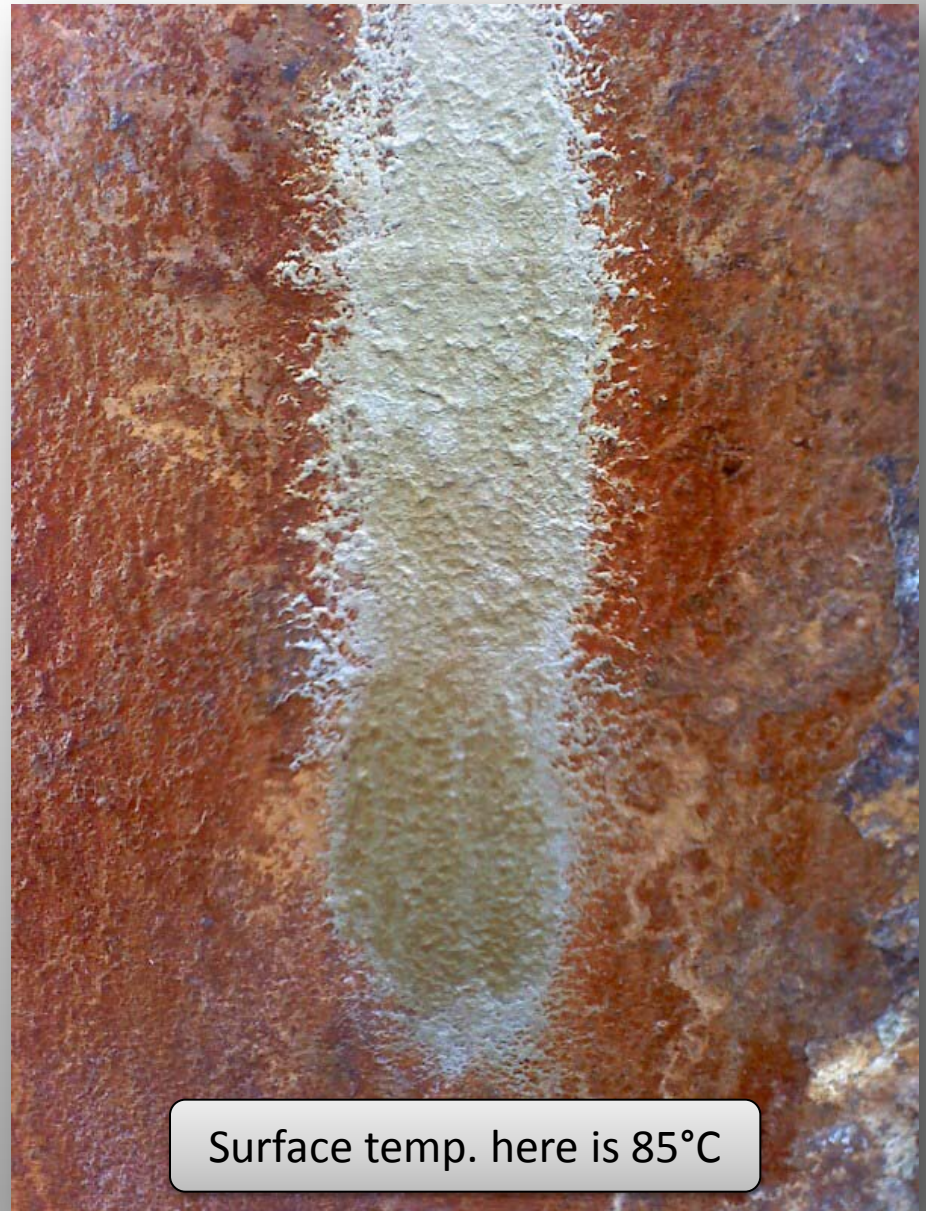
Although we were afraid to apply Rust Grip below the HPC or HSC layer, we applied a brushstroke on the bare hot corroded surface to see its behavior.

Surface temp. here is 85°C

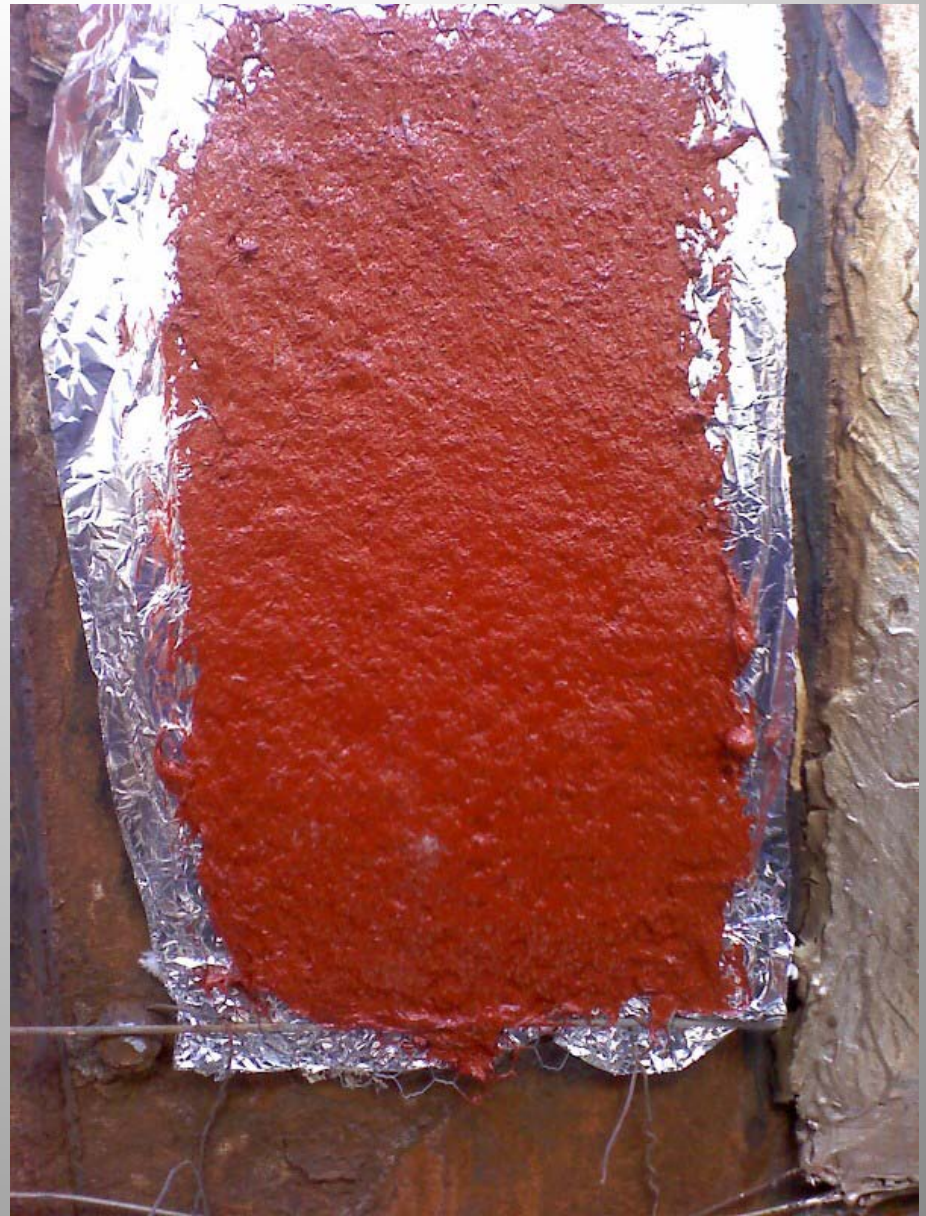
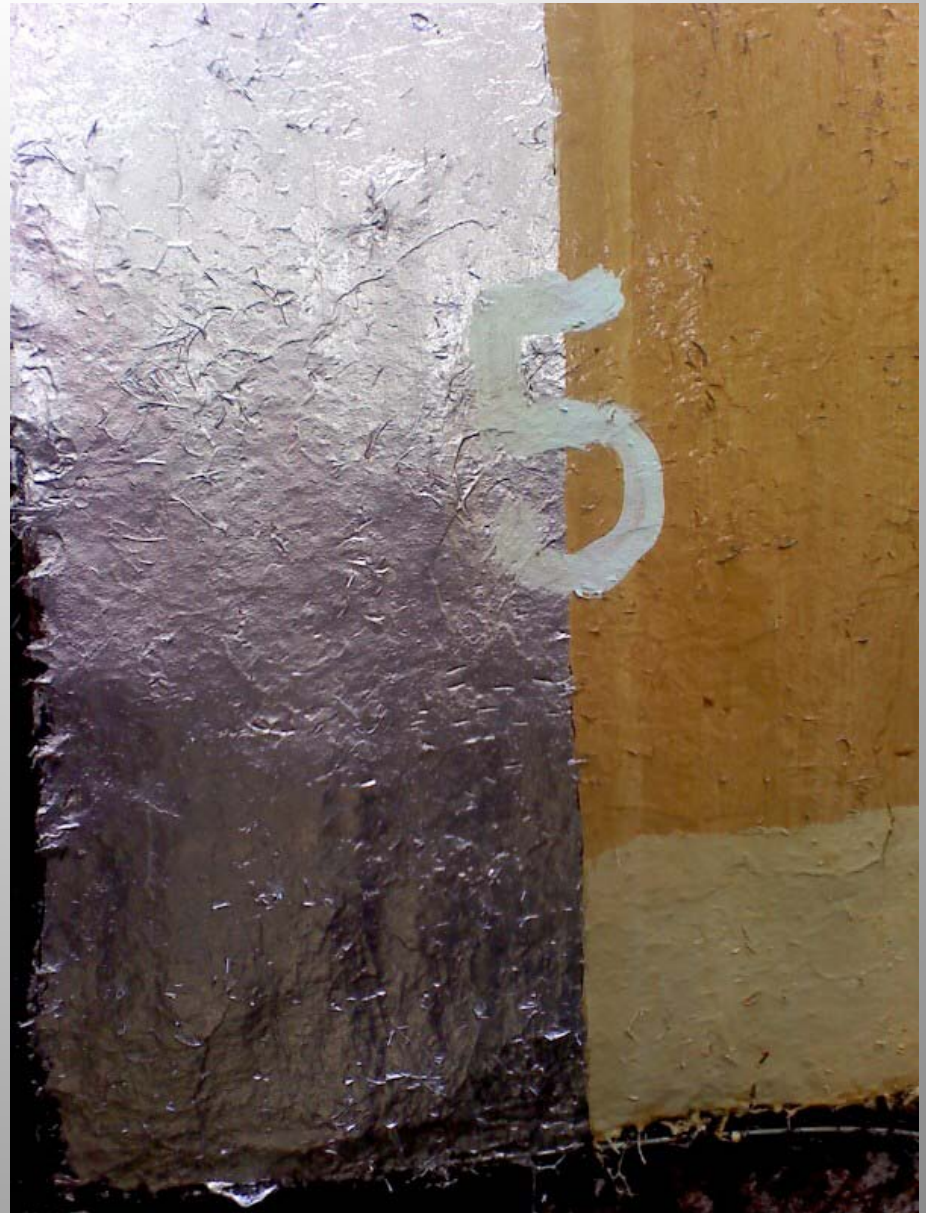
Alternative systems are also being tested.

The alternatives systems that are also being tested, include:

- 1 - An epoxy coating for protecting the steel.
- 2 – Mineral wool supported with a wire mesh.
- 3 – A coating system to seal and protect the mineral wool from the environment.
