MERTIN GM ~ AUTO DETAILING SHOP CHILLIWACK

2003

RUST GRIP (NS)®

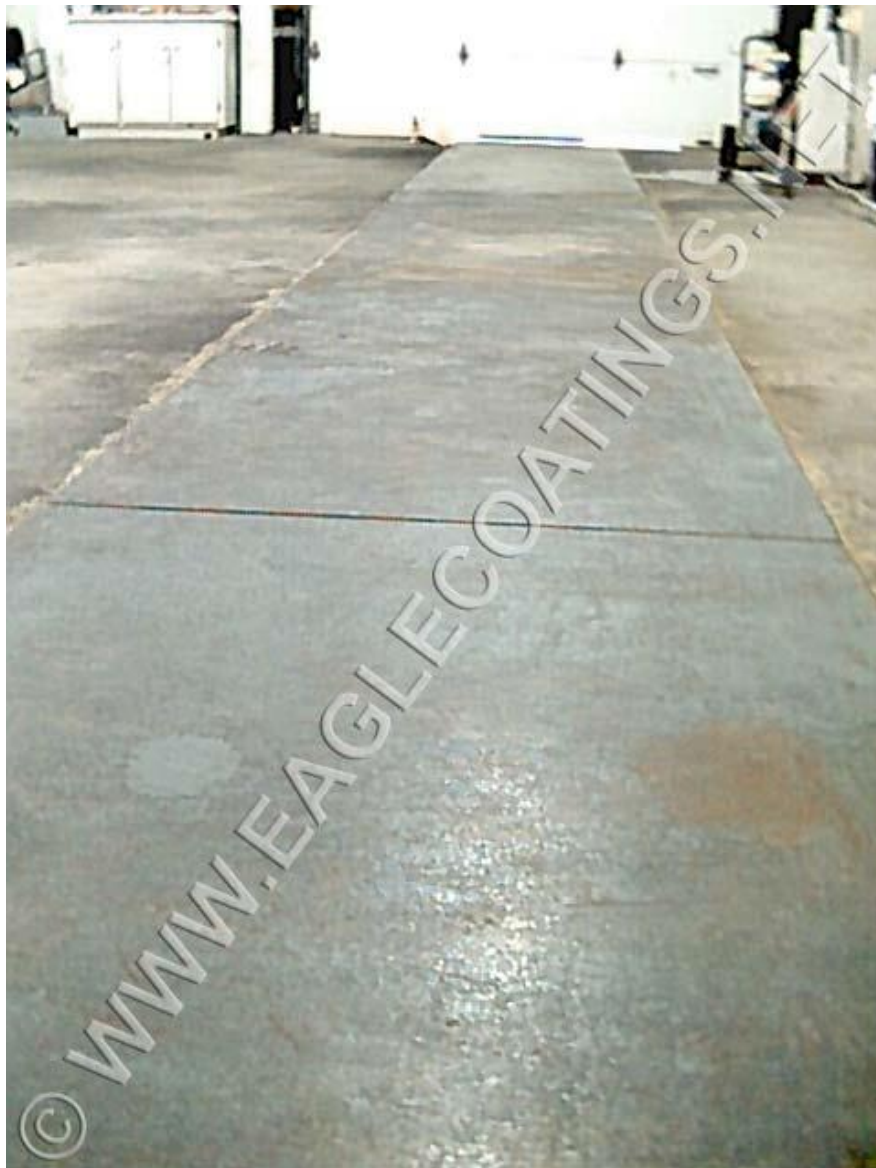
Problem: This metal plate covers an oil change pit in a converted Auto Detailing Shop. Due to the various chemicals, acids and solvents used, the paint wouldn't last more than a few months before flaking and peeling. Also, the surface became slippery which was a WCB, employee and management concern.
