HEAVY DUTY TRANSMISSION SHOP

2004

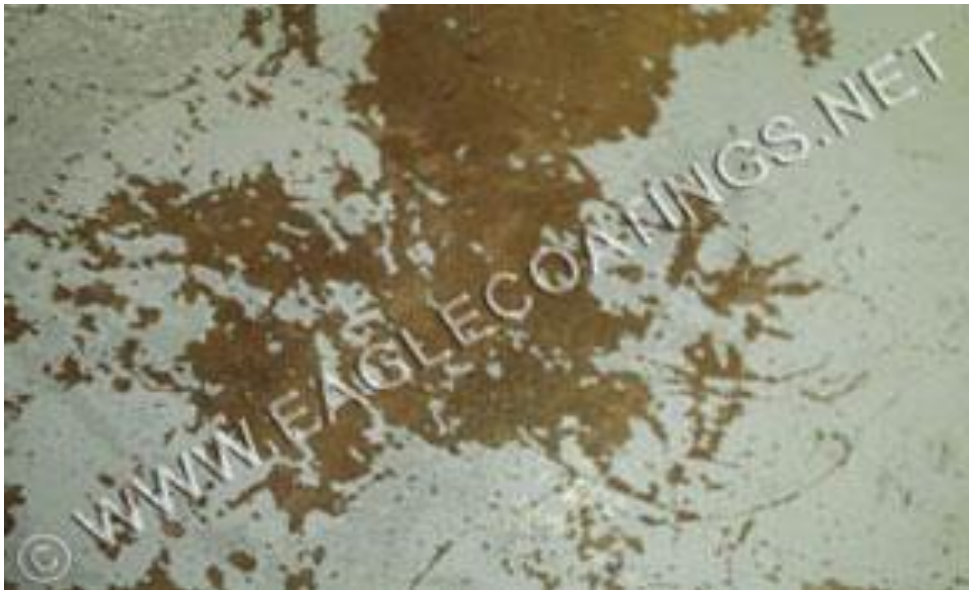
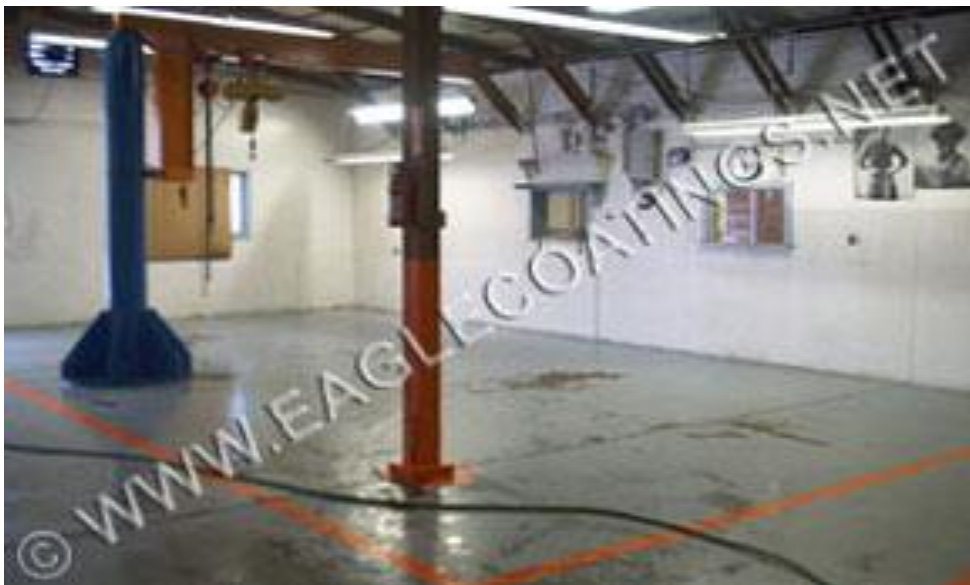
Problem: The epoxy coating was delaminating and the floor was slippery creating a concern for management, employees and WCB.

Solution: Remove any loose existing coating by hand tool and then pressure wash to a clean, dry and sound substrate ready to accept a coating system of **RUST GRIP (NS)®**. **RUST GRIP (NS)®** enters the pores of the concrete and the epoxy coating and actually becomes part of the surface instead of just bonding to the top like all other coatings

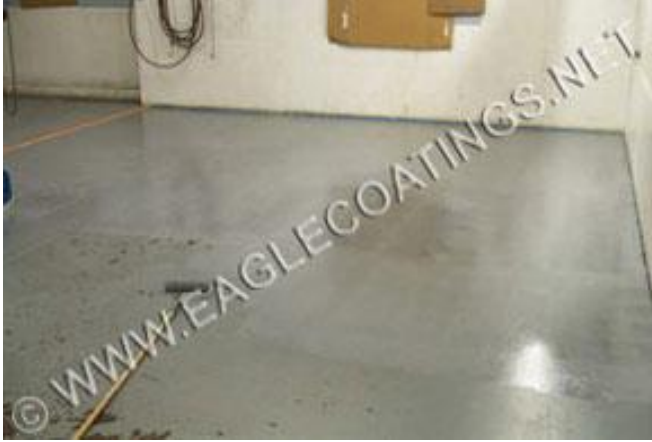
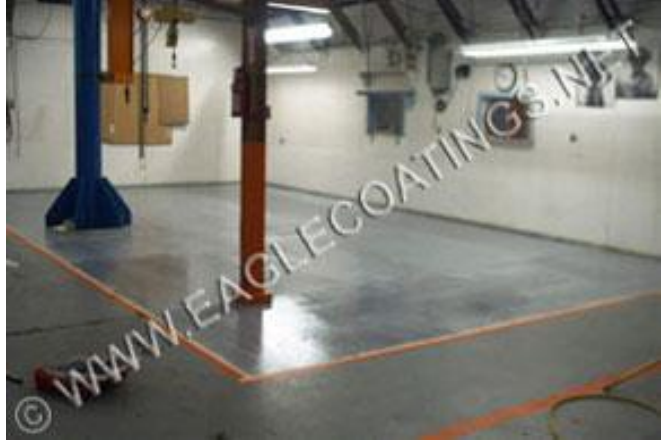
A primer coat of **RUST GRIP (NS)**® was applied and then a small amount of non aggressive aggregate was broadcast and back rolled to provide a slip resistant surface that was also easy to clean.

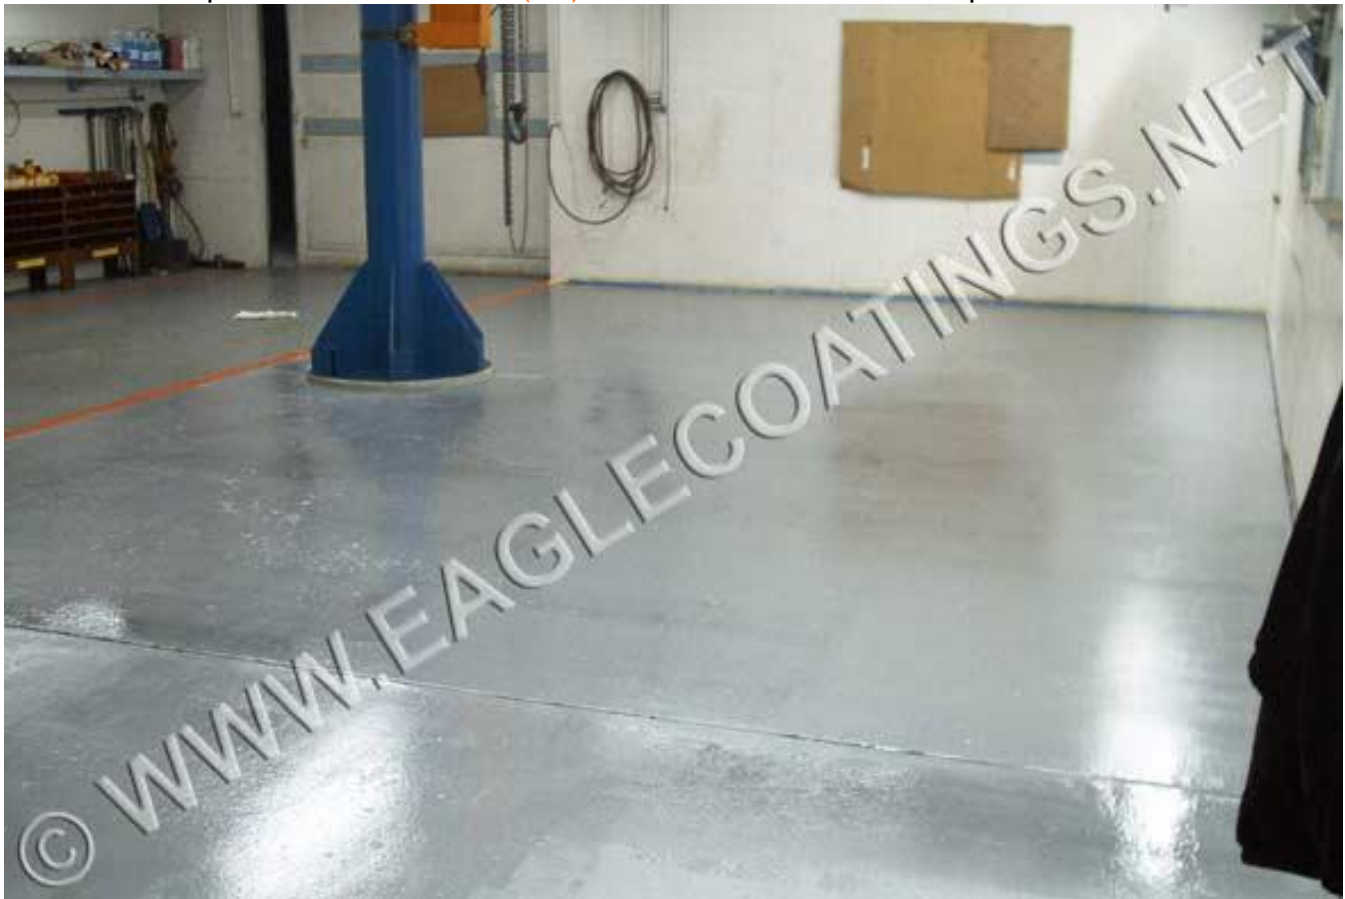
A top coat of **RUST GRIP (NS)**® was cross hatched for a permanent seal.
