INGENIKA TUG BOAT

April 2010

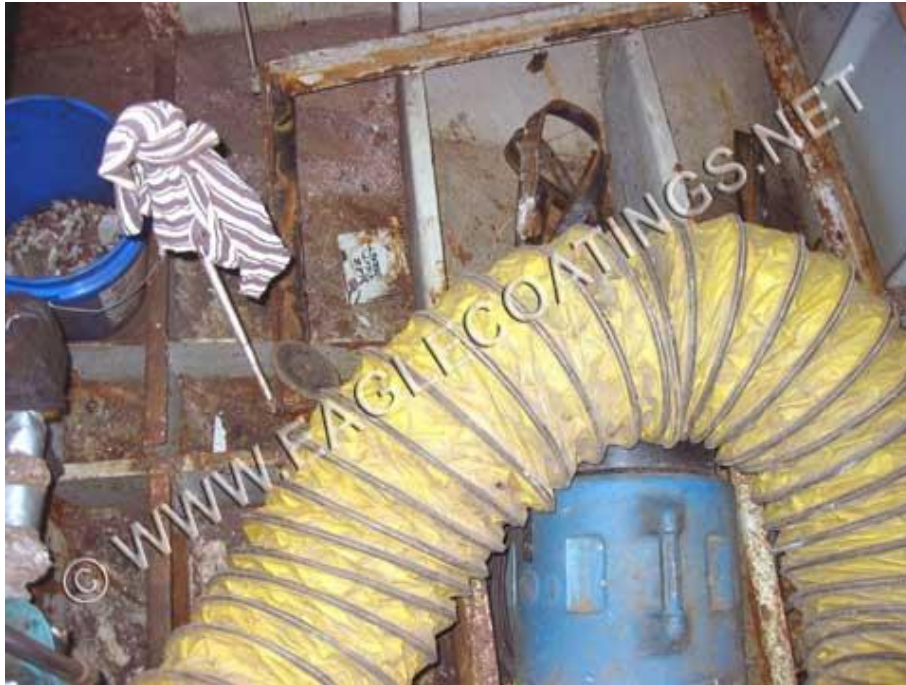
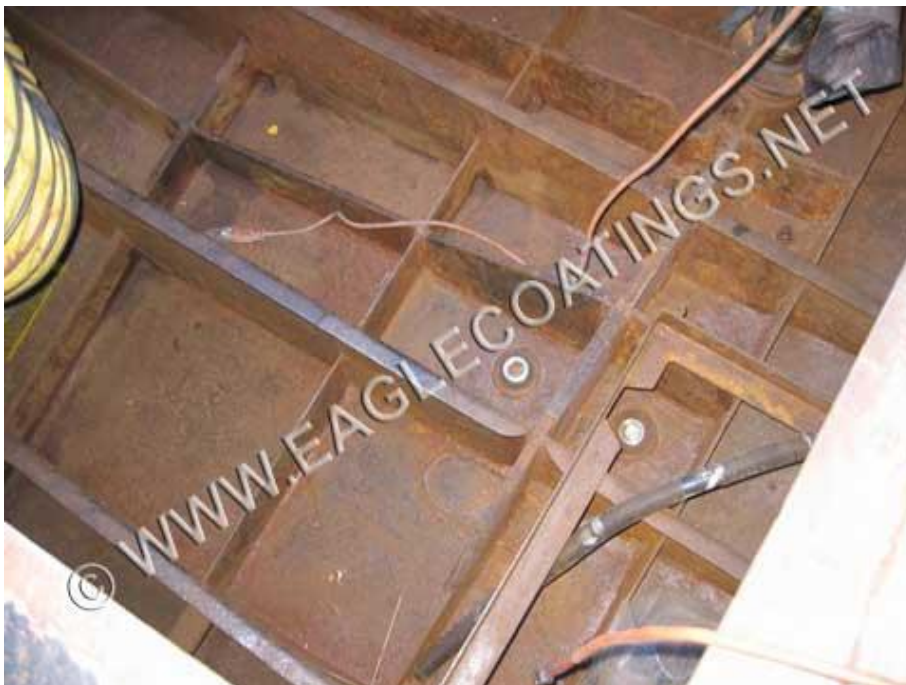
Engine Room forward facing Engines removed, grease, oil and ponding salt water on surfaces Prep done with a needle/scalar chisel & grinder to remove pack rust, then washed down with acetone.

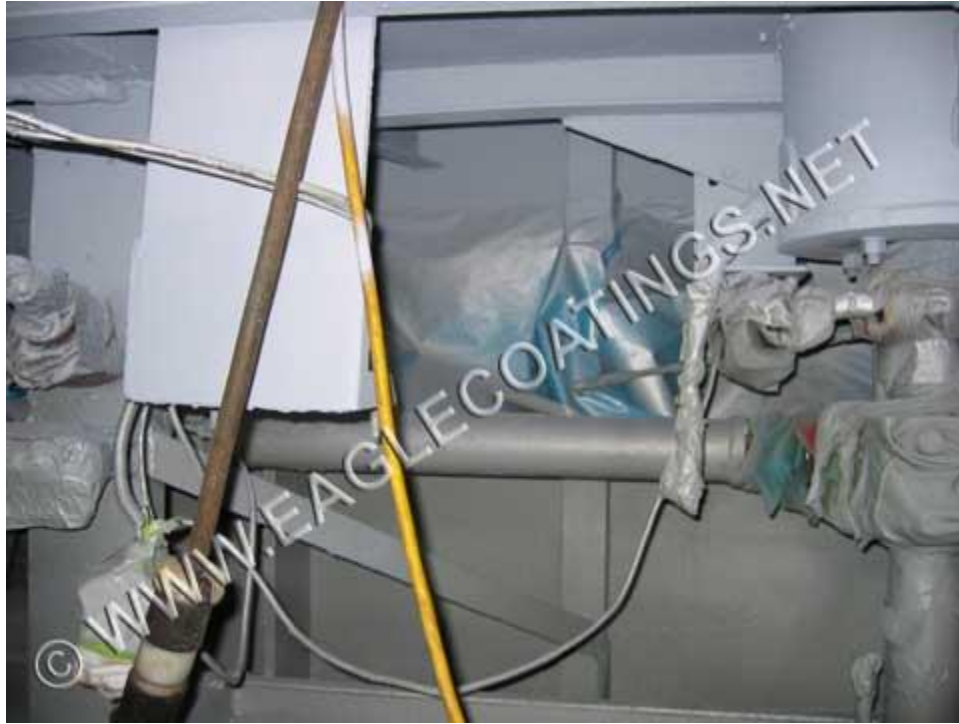
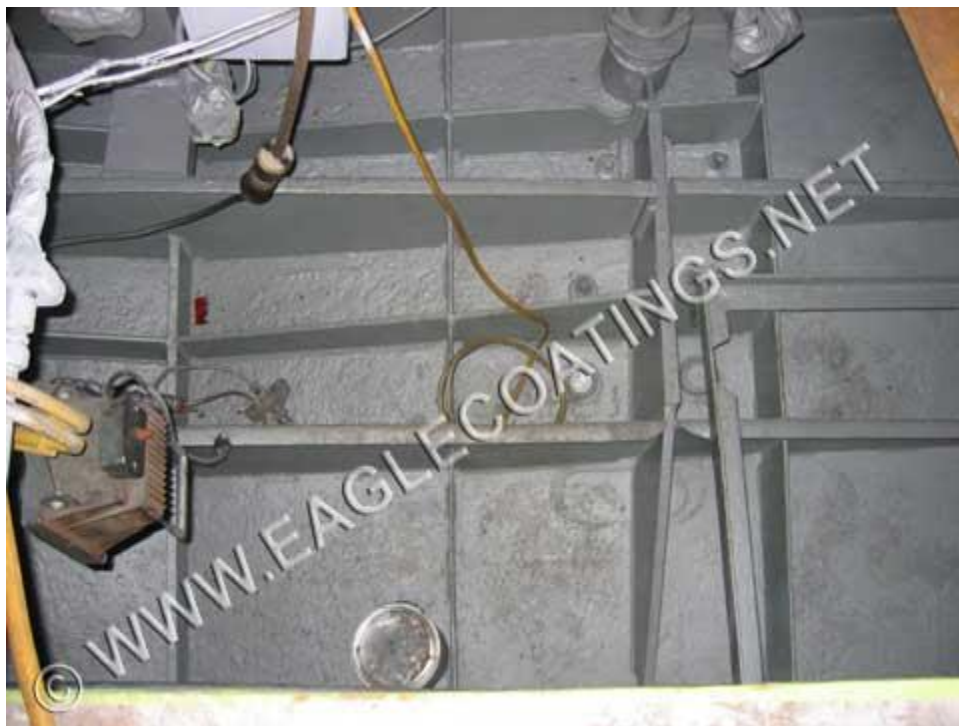
FIVE YEARS LATER AND STILL LOOKING FABULOUS
