## WINERY OSOYOOS, BC

July, 2004

**SUPERBASE (HS)** ® and **SUNSHIELD** ® with a top coat of **ENAMOGRIP** ®.

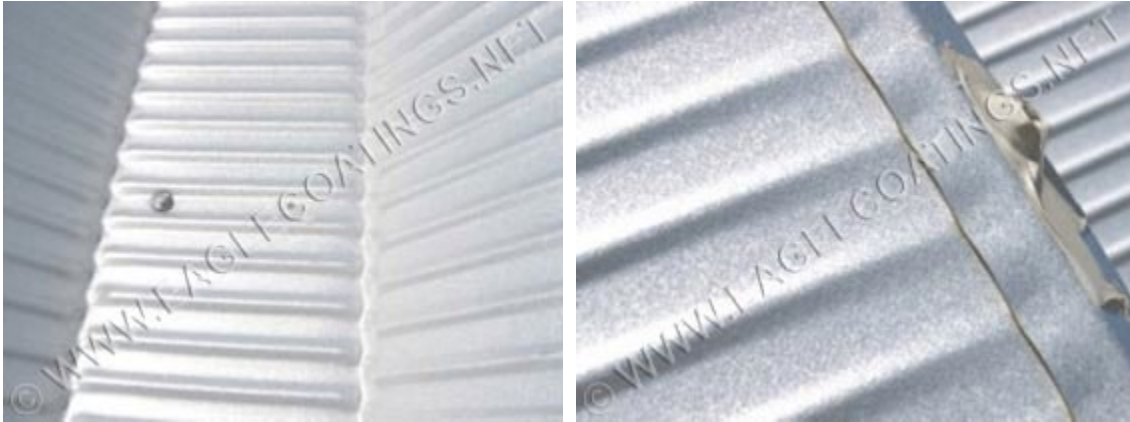
## Corrosion evident on the exposed panel edges

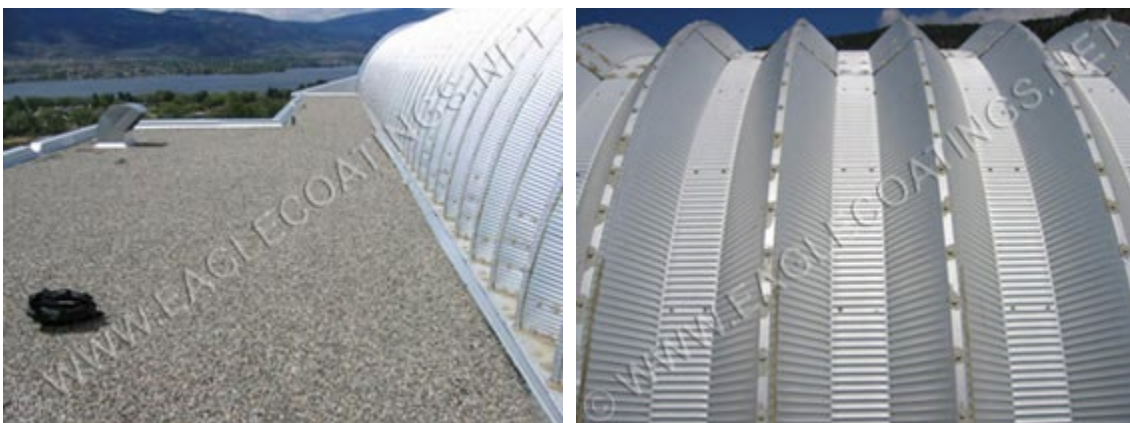
**Potential problem areas identified are: loose or missing nuts/bolts, defective washers, seams, flashings, ponding water and heat expansion. Polyurethane caulking on bolt heads and bottom base plate seams (below) did not resolve the issue, although caulking did not cover all bolt heads or seams. Temperatures in the Osoyoos area can climb to 40°C or more. This places considerable heat load on metal roofs, especially where the substrate has been insulated on the underside and closed in, offering little to no ventilation. During the application below, it was impossible for one to hold their hand onto the metal substrate, with ambient temperatures reaching 40.5°C.**

**EAGLE recommended a unique monolithic coating system, which would address all of the potential problem areas:**

- Caulking of all of the seams and bolts with **SUPERTHERM**® to ensure a waterproof substrate that is resistant to UV and ponding water.
- A base coat **SUNSHIELD**® would be applied over the total surface area to insulate and prevent further heat expansion of the substrate. Added benefits would include a flexible coating, which provides additional waterproofing over the complete substrate
- A top coat of **ENAMOGRIP**® tinted as per customer who wished to maintain the aluminum appearance as much as possible. Added benefits include an outstanding low maintenance protective coating, which provides semi-gloss retention, color retention, chalk resistance, water resistance and UV resistance. The corrosion on the panel edges will no longer be able to spread once it is permanently sealed under this coating system.

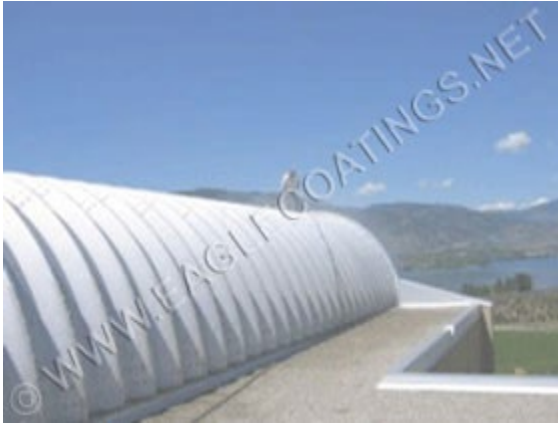
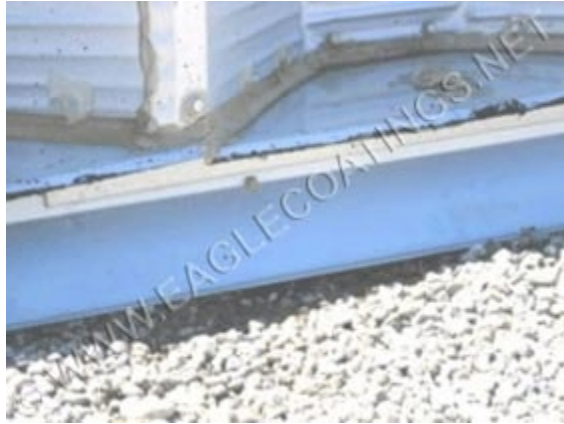
**Preparation of the substrate involved water blasting the roof clean of all loose debris and dirt (common in this wind blown area) Note the water ponding at the base (lower right photo). This flashing does not slope away from the seams. These areas had to be hand dried to ensure the substrate was completely dried to accept the coating system.**

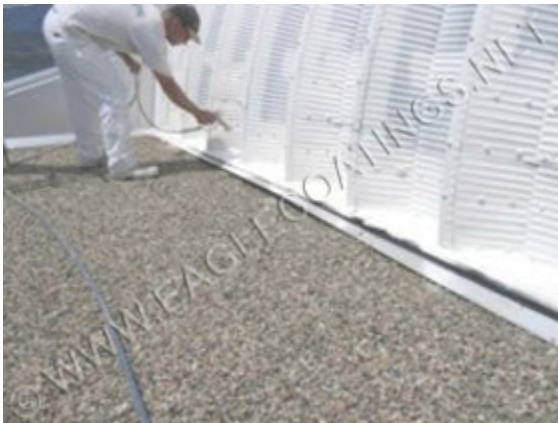
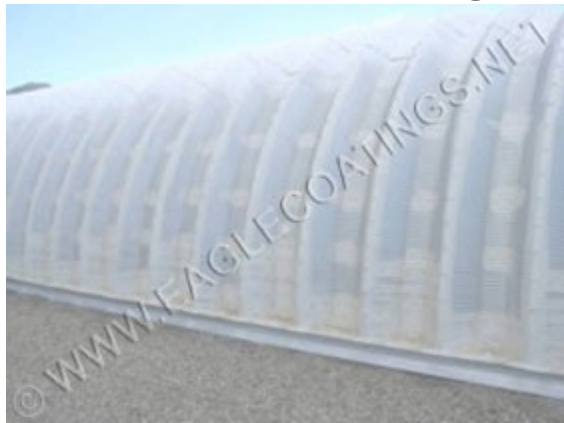
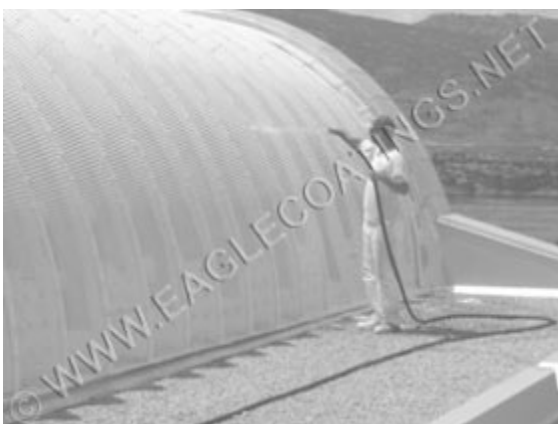
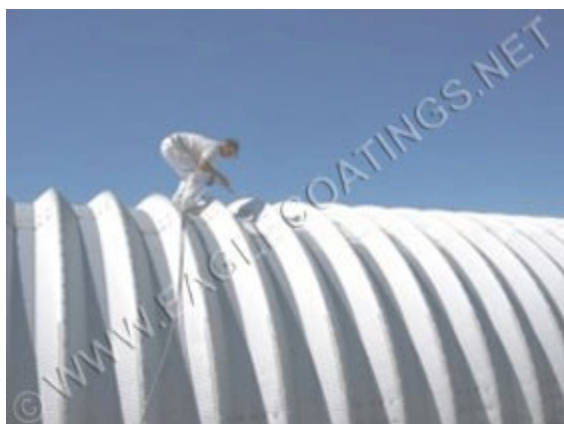
**SUPERBASE (HS) ® applied on all bolts and seams at 30SqFt p/gal. The bottom base flashing was applied liberally with added material to accommodate the anticipated ponding water.**

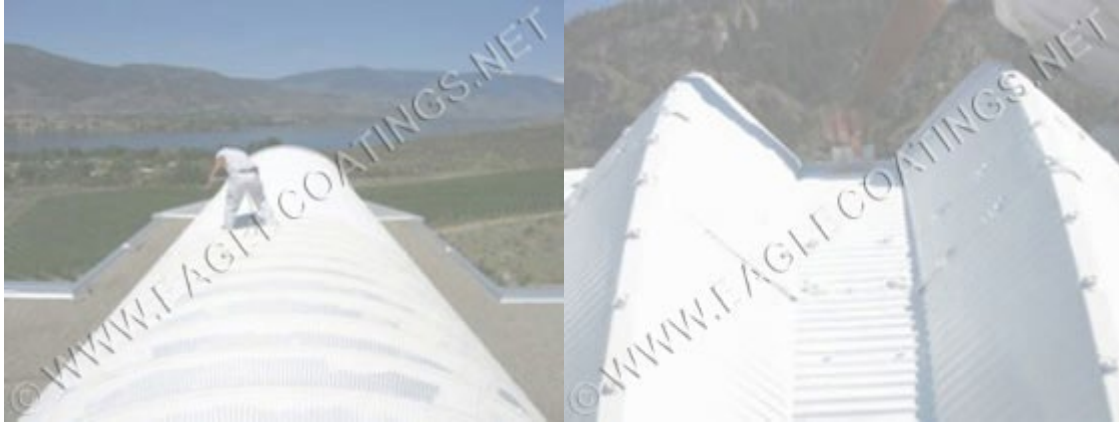
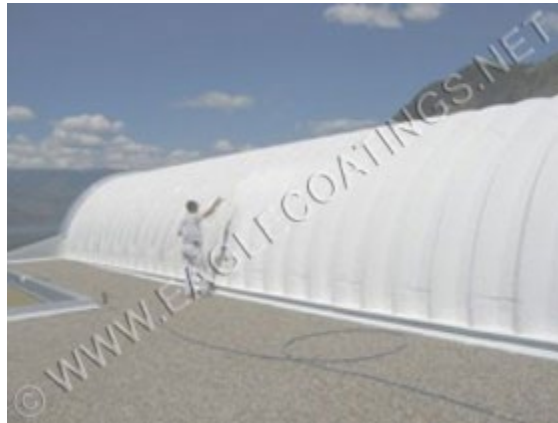
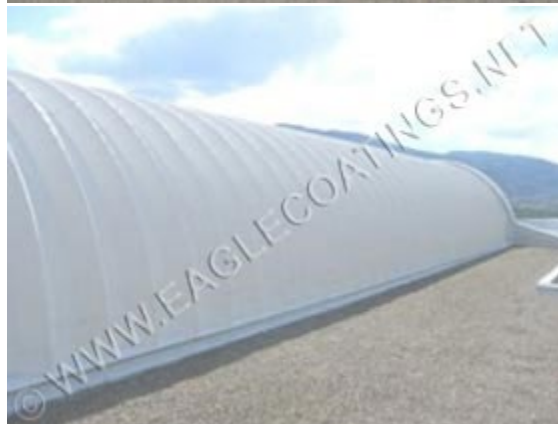
# **SUNSHIELD**® applied at 16mil WFT to dry down to 7.38mil DFT
