CHELSEA GARDENS

1998

RUST GRIP® and then topcoated with **ENAMO GRIP**®

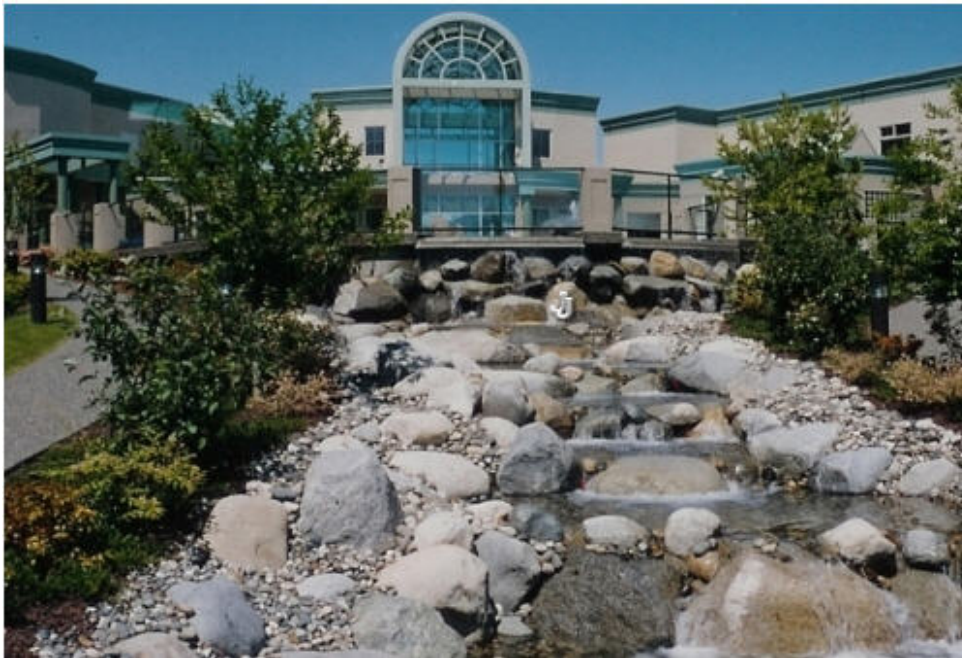
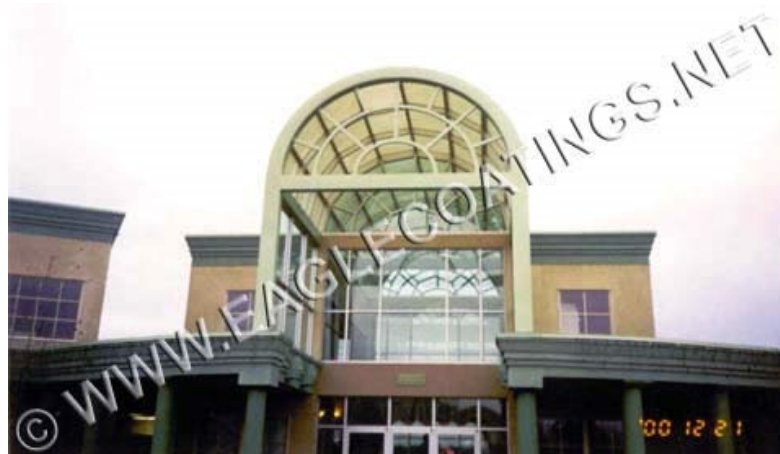
This metal arch was being attacked by the chlorine in the swimming pool below. The Epoxy coating had completely failed after about 2 years. In 1998 we primed the metal first with **RUST GRIP**® and then topcoated with 2 coats crosshatched of **ENAMO GRIP**®. This picture was taken in 2000 on our two year follow up. In 2004 the coating system still looks new. This coating system provides a 10 year manufacturer \ contractor material and labour warranty.
