CHEVRON OIL, MISSISSIPPI

November 2003

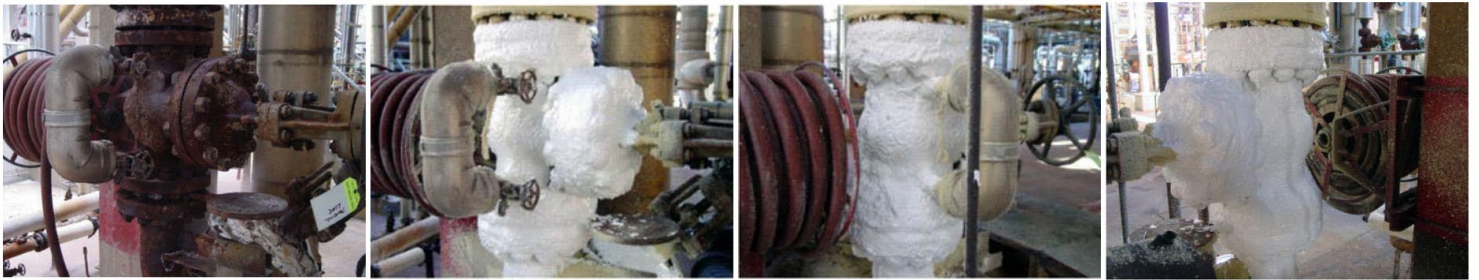
A steam valve running **600°F (315°C)**, which has never been able to be insulated before. [HPC® COATING](#) applied in a very thin coat, directly to the valve while operating. After the initial coat was sprayed on and steamed out, the additional coats built up quickly. The white look is because the next day, the [HPC® COATING](#) was overcoated with [SP LIQUID MEMBRANE](#)® white high gloss to protect [HPC® COATING](#) from weathering and UV.

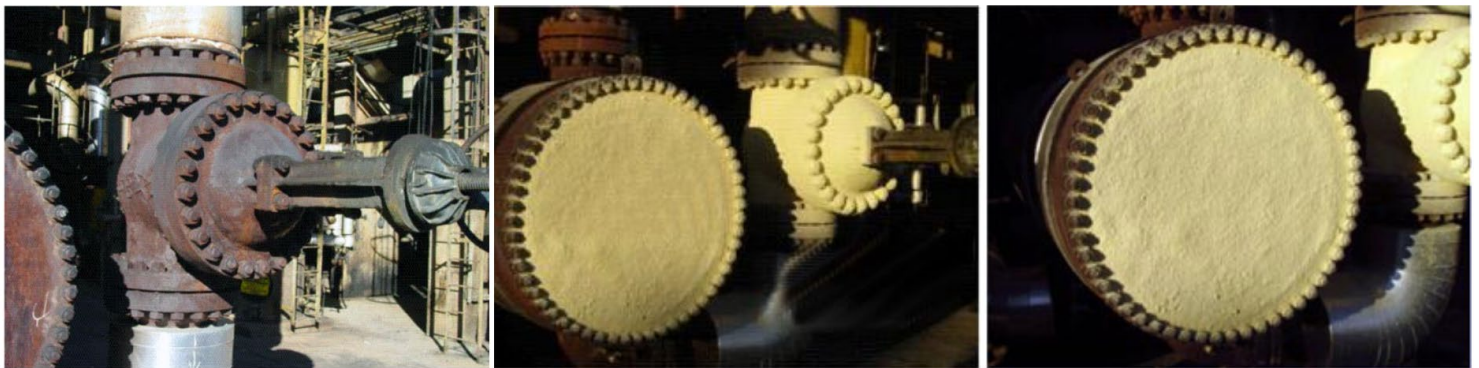
Another Valve location running **489°F (254°C)**. Personnel applied 350 mils DFT (350/1000 " or approximately 1/3 ") of [HPC® COATING](#) to see what the temperature would settle to and it was **180°F (82°C)**. The other side was applied at 750 mils DFT (3/4 ") and the temperature settled to **135°F (57°C)**. The "dollar plate" (end of the tube showing bolts around circle) immediately dropped to **135°F (57°C)**.

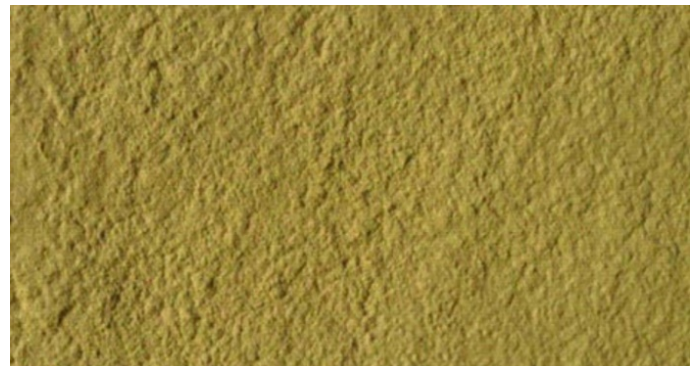
Close-Up of [HPC® COATING](#) sprayed using the new **Graco Texspray RTX 1000**.
