## ROANOKE CEMENT – VIRGINIA

January 2010

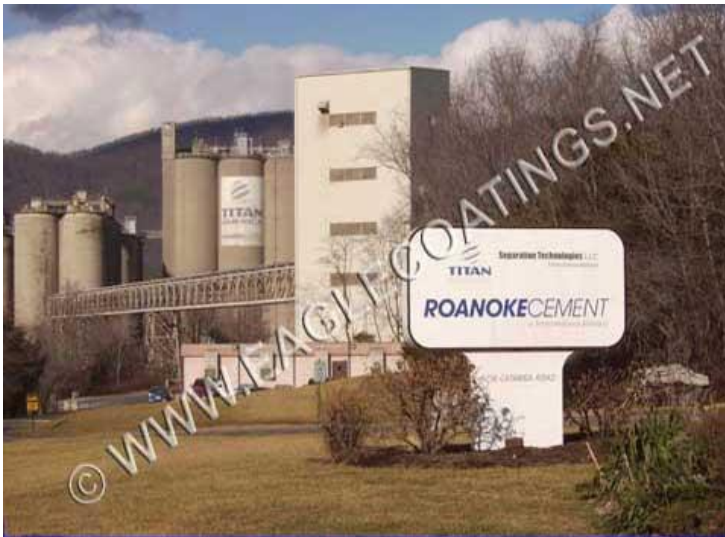
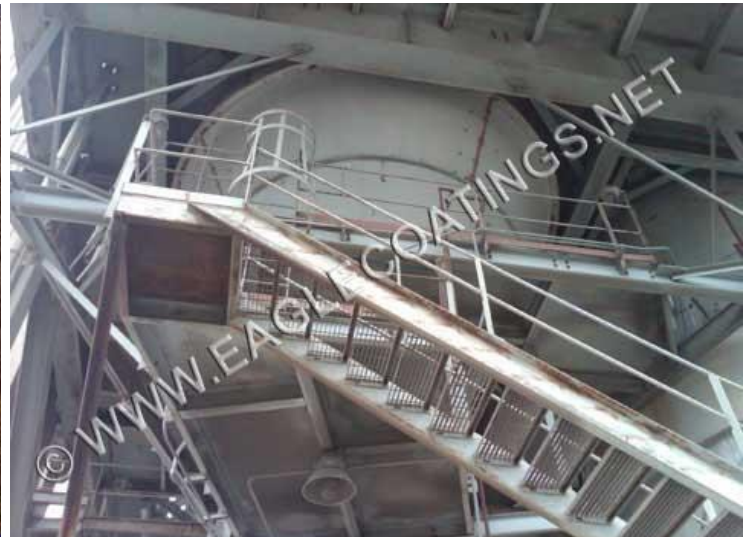
The Cyclone was located 50 feet in the air and there was blowing snow during this time.

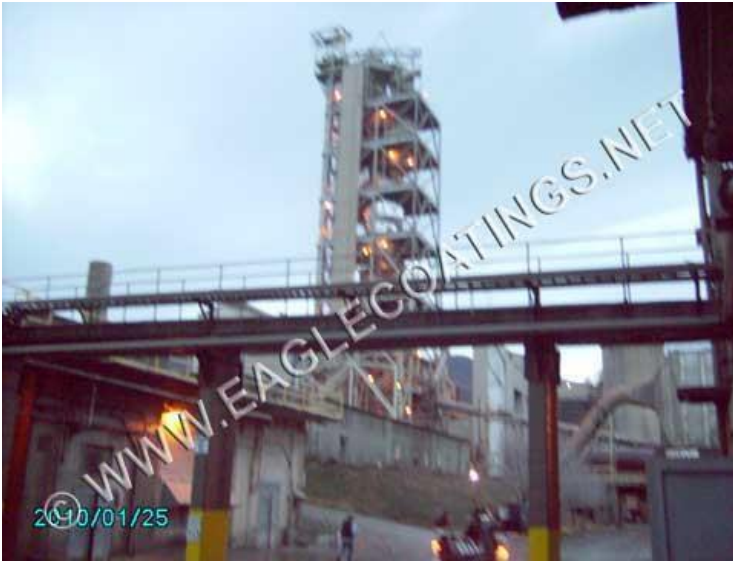
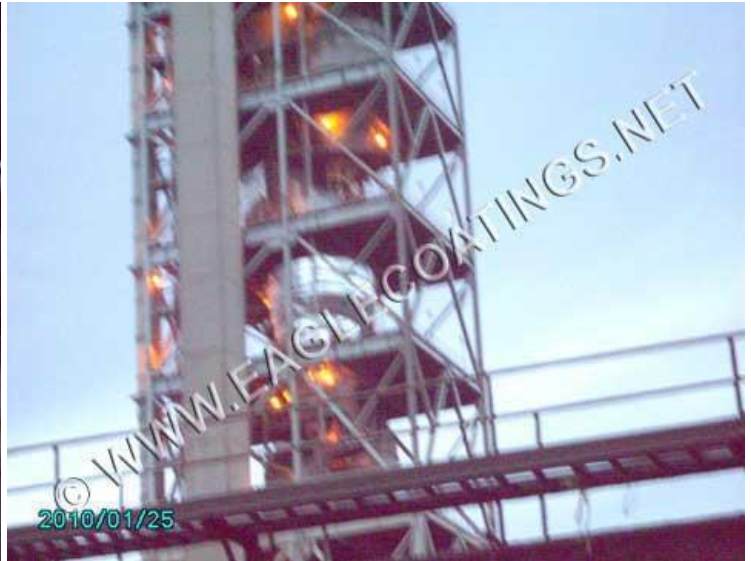
Thermal wrap to retain heat

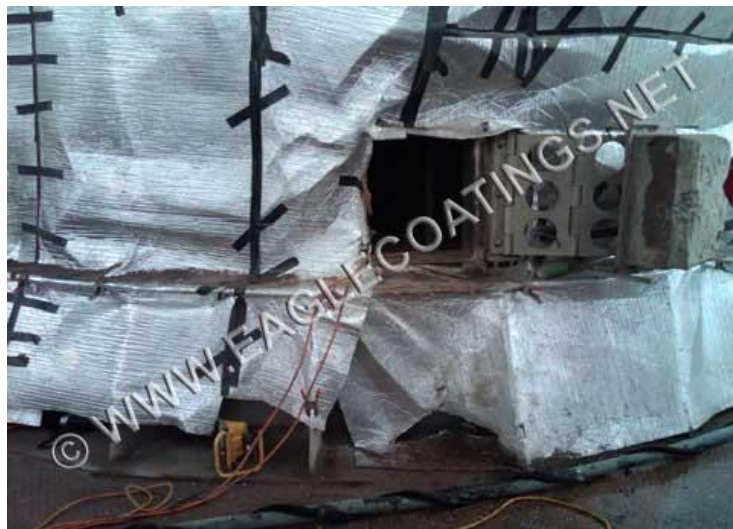
Heat applied to bring up to application temp.

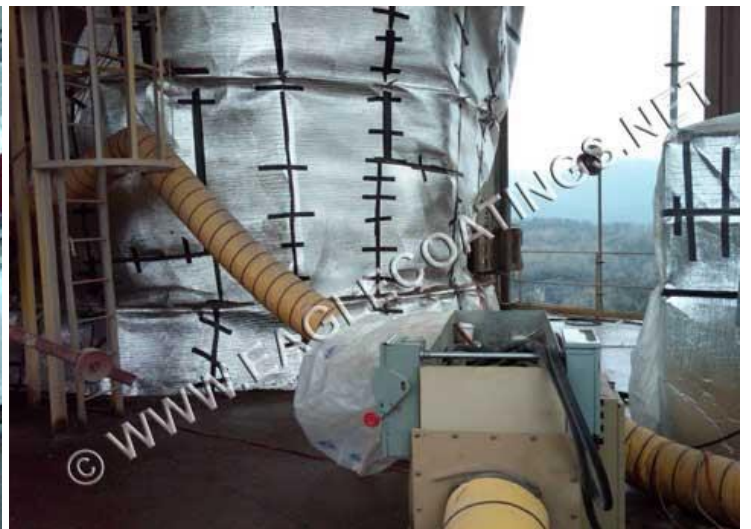
Assembly Scaffolding

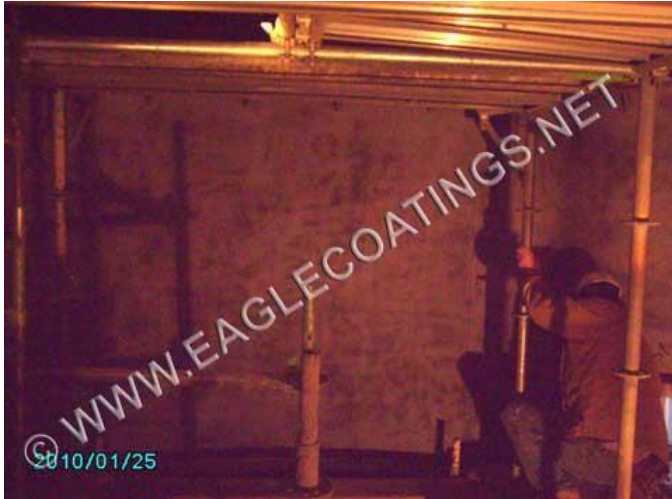
Inside Preparation

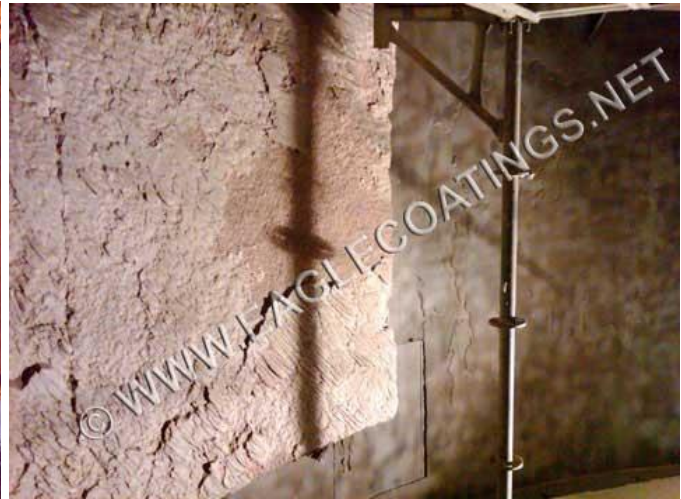
Sandblasting to SSPC – SP6 Commercial Blast. Flash and mild rust are acceptable

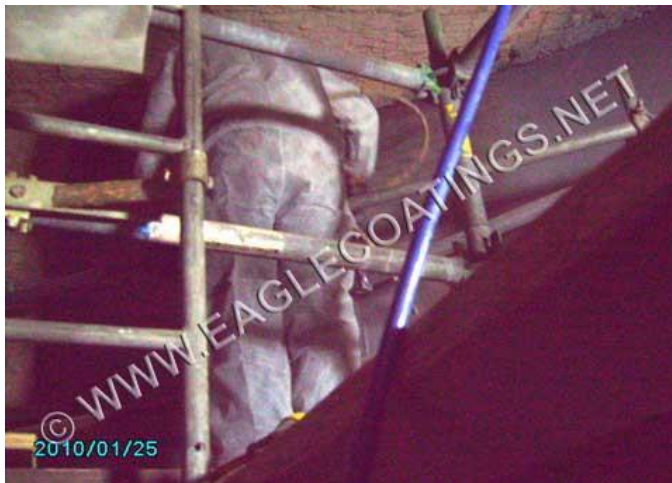
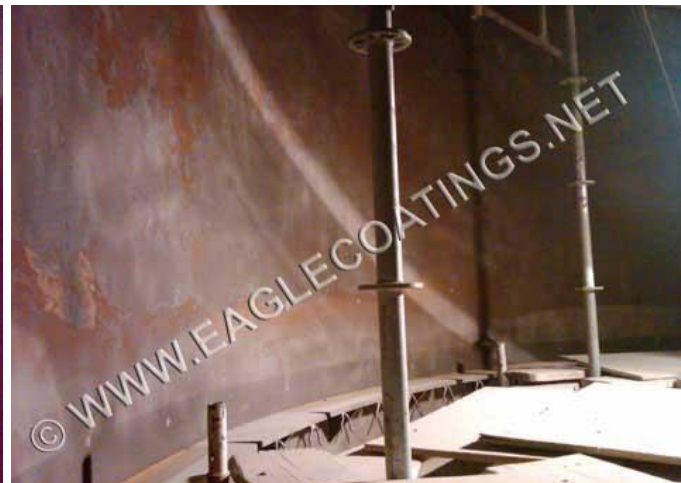
Sand Blasted Metal Surface to approximately a 2 mil profile

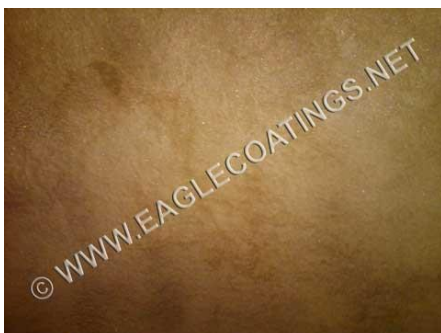
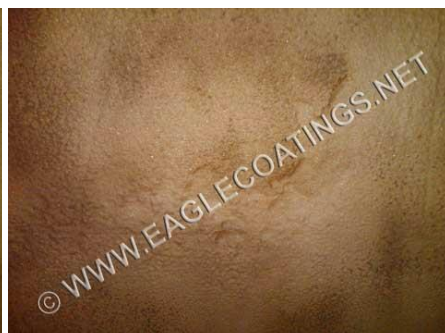
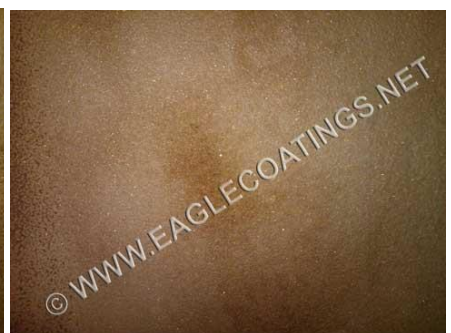
RUST GRIP® applied to 4mils dry film thickness over the highest peak of the surface profile.

The system we used was to first apply RUSTGRIP® a patented and certified Functional Coating for Encapsulation of Rust and Bio-hazards. This functional coating will prevent any further corrosive deterioration of the metal.

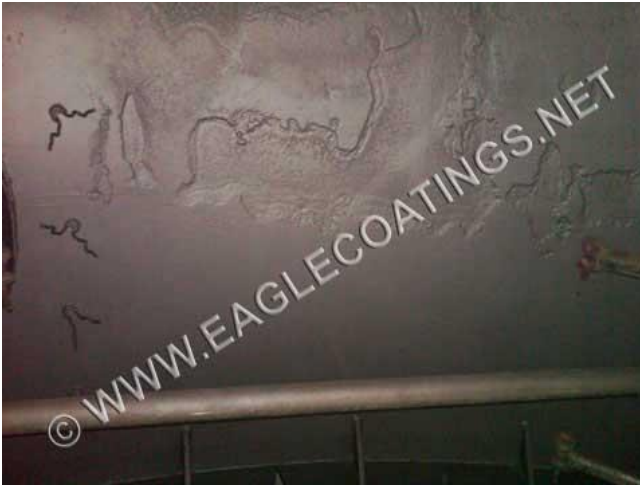
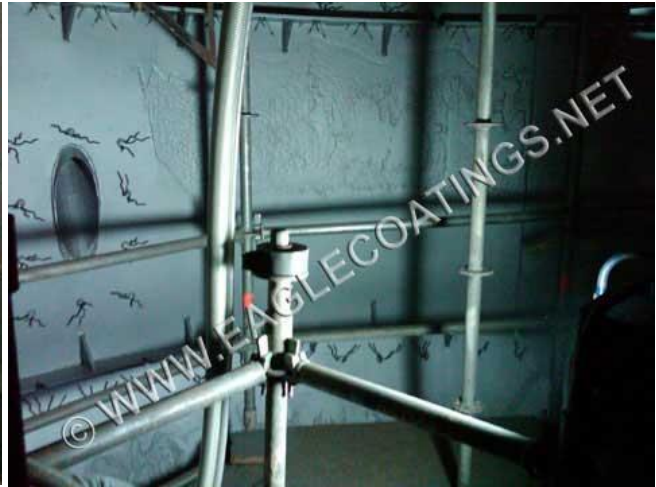
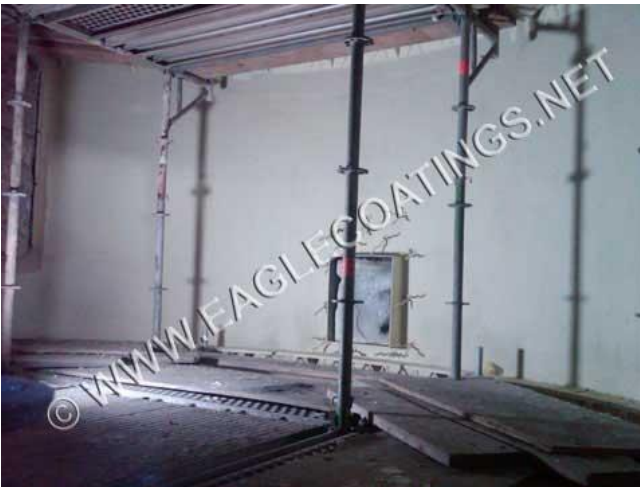
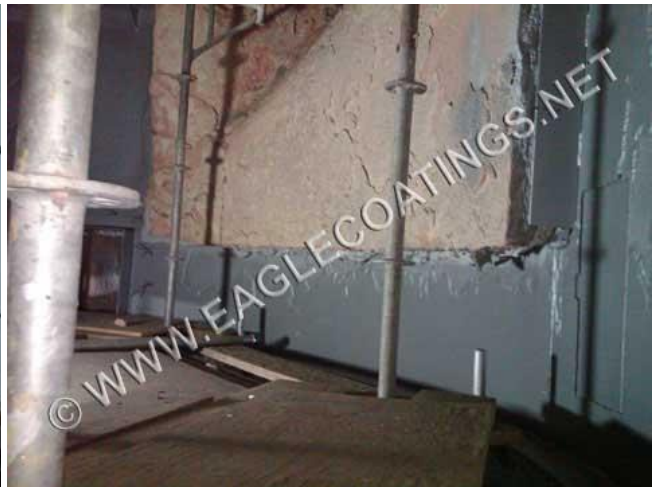
Mixing the HPC® COATING

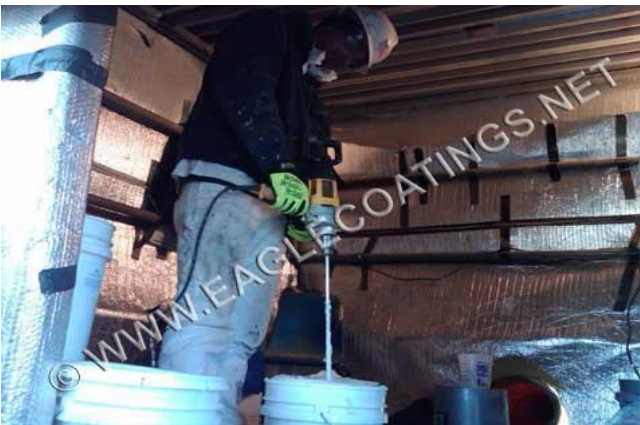
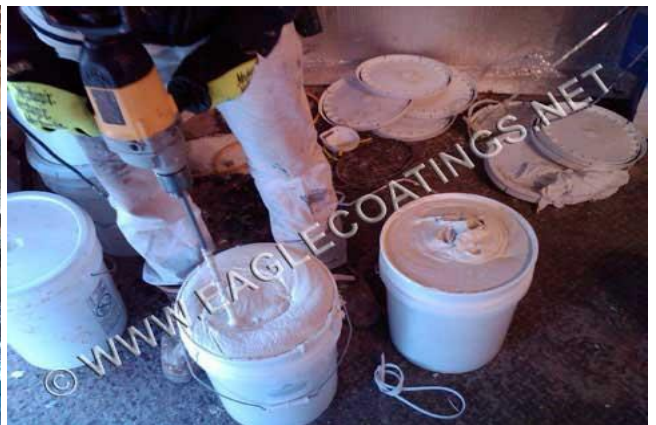
HPC® COATING Application to the required dry film thickness depending on the temperature.

A coating of HPC® COATING a Functional **Ceramic Insulation Coating Engineered to Block Heat up to 232°C / 450°F** protects the RUSTGRIP from the heat and helps to control the cold spots which cause spot condensation and corrosion that is very tough to control. Coating with the HPC COATING stabilizes the surface temperature across the surface to control these cold spots.

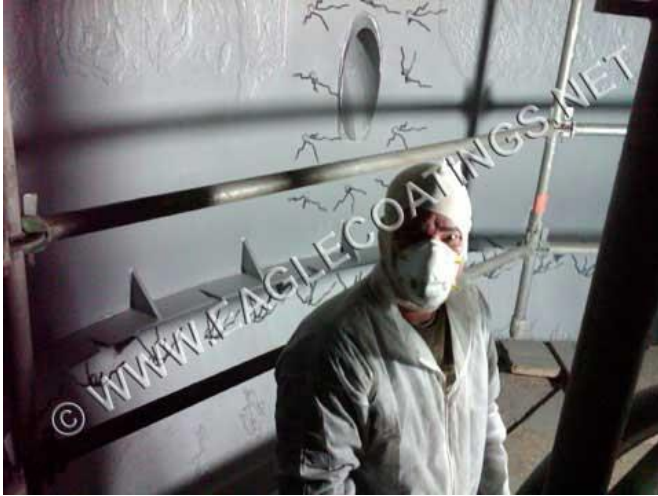
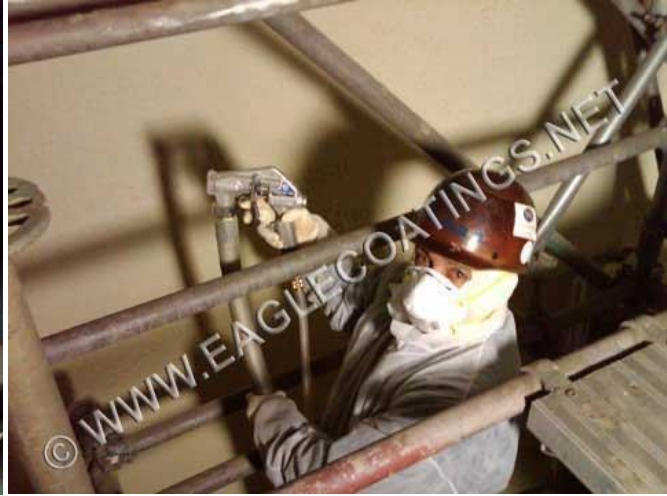
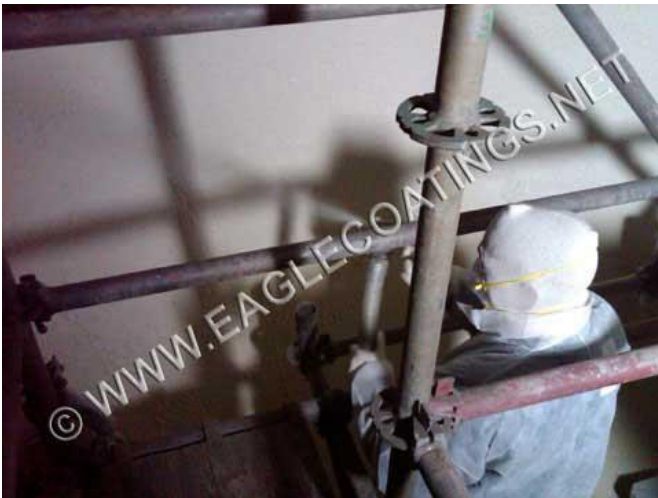
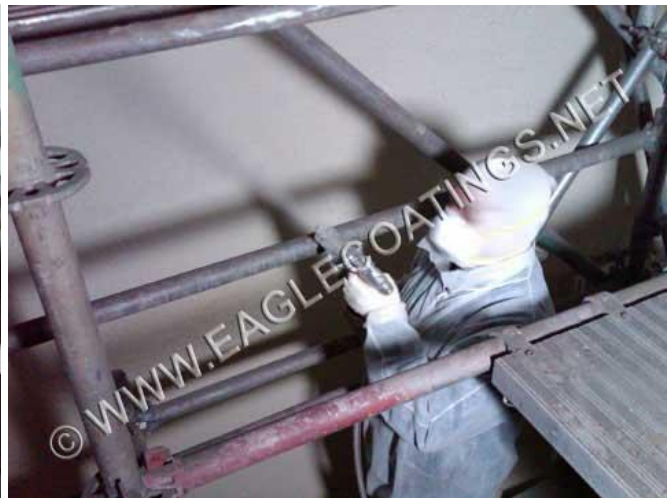
Top coat of **SUPERTHERM®** applied to 10mils dry film thickness

A top coat of SUPERTHERM® was applied to protect the HPC® COATING.
