VANCOUVER ABORIGINAL FRIENDSHIP CENTER VANCOUVER 1997

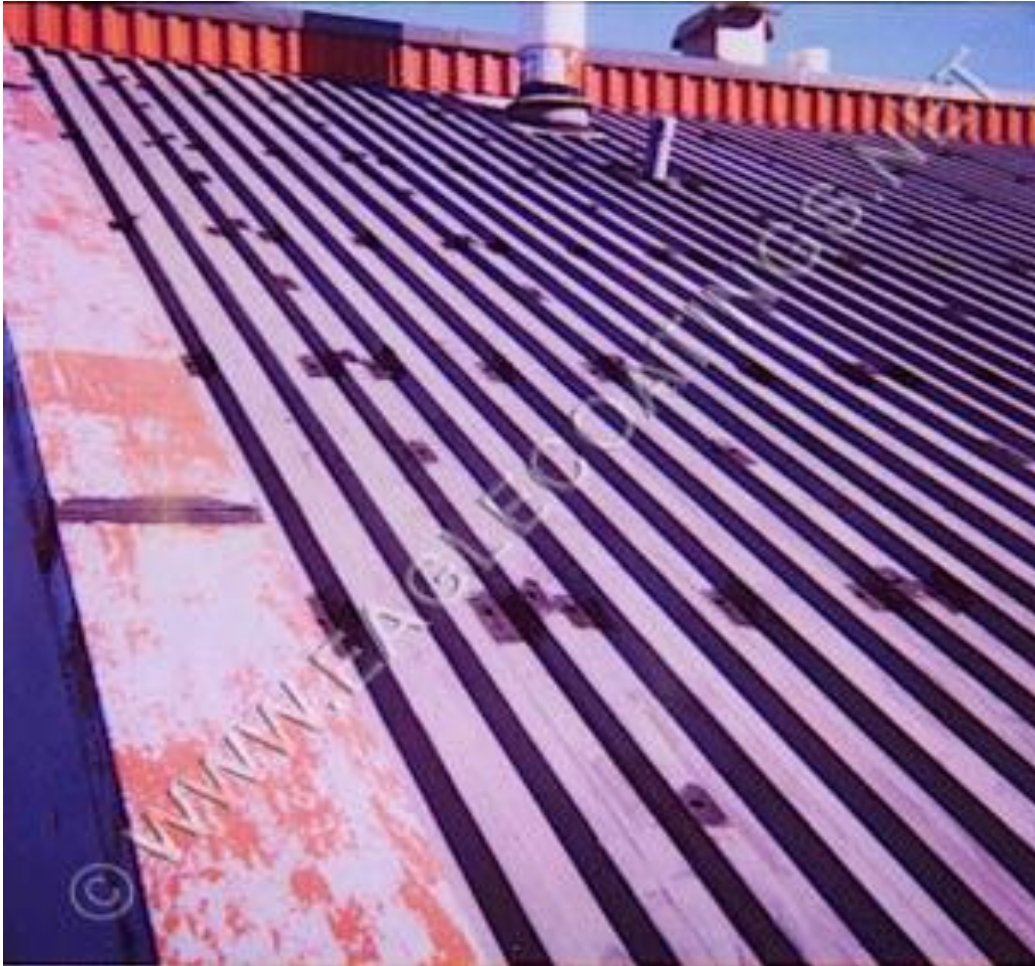
Problem: leaking and rusting metal roof, flaking coating on flashing, heat expansion \ contraction of the substrate leading to opening of seams and screws popping out.

Solution: A Function Coating System consisting of **RUST GRIP® Rust and Biohazard Encapsulation** primer coat to permanently seal in the rusting metal

SUPERBASE (HS)® Acrylic Caulking / Membrane to caulk seams and screws

SUPERTHERM® Ceramic Thermal Barrier Coating Engineered to Repel Heat Base Coat to insulate and stop heat expansion plus added UV protection

ENAMO GRIP® Low Maintenance Top Coat to provide a lasting impact resistant, low maintenance finish up to and including GRAFFITI

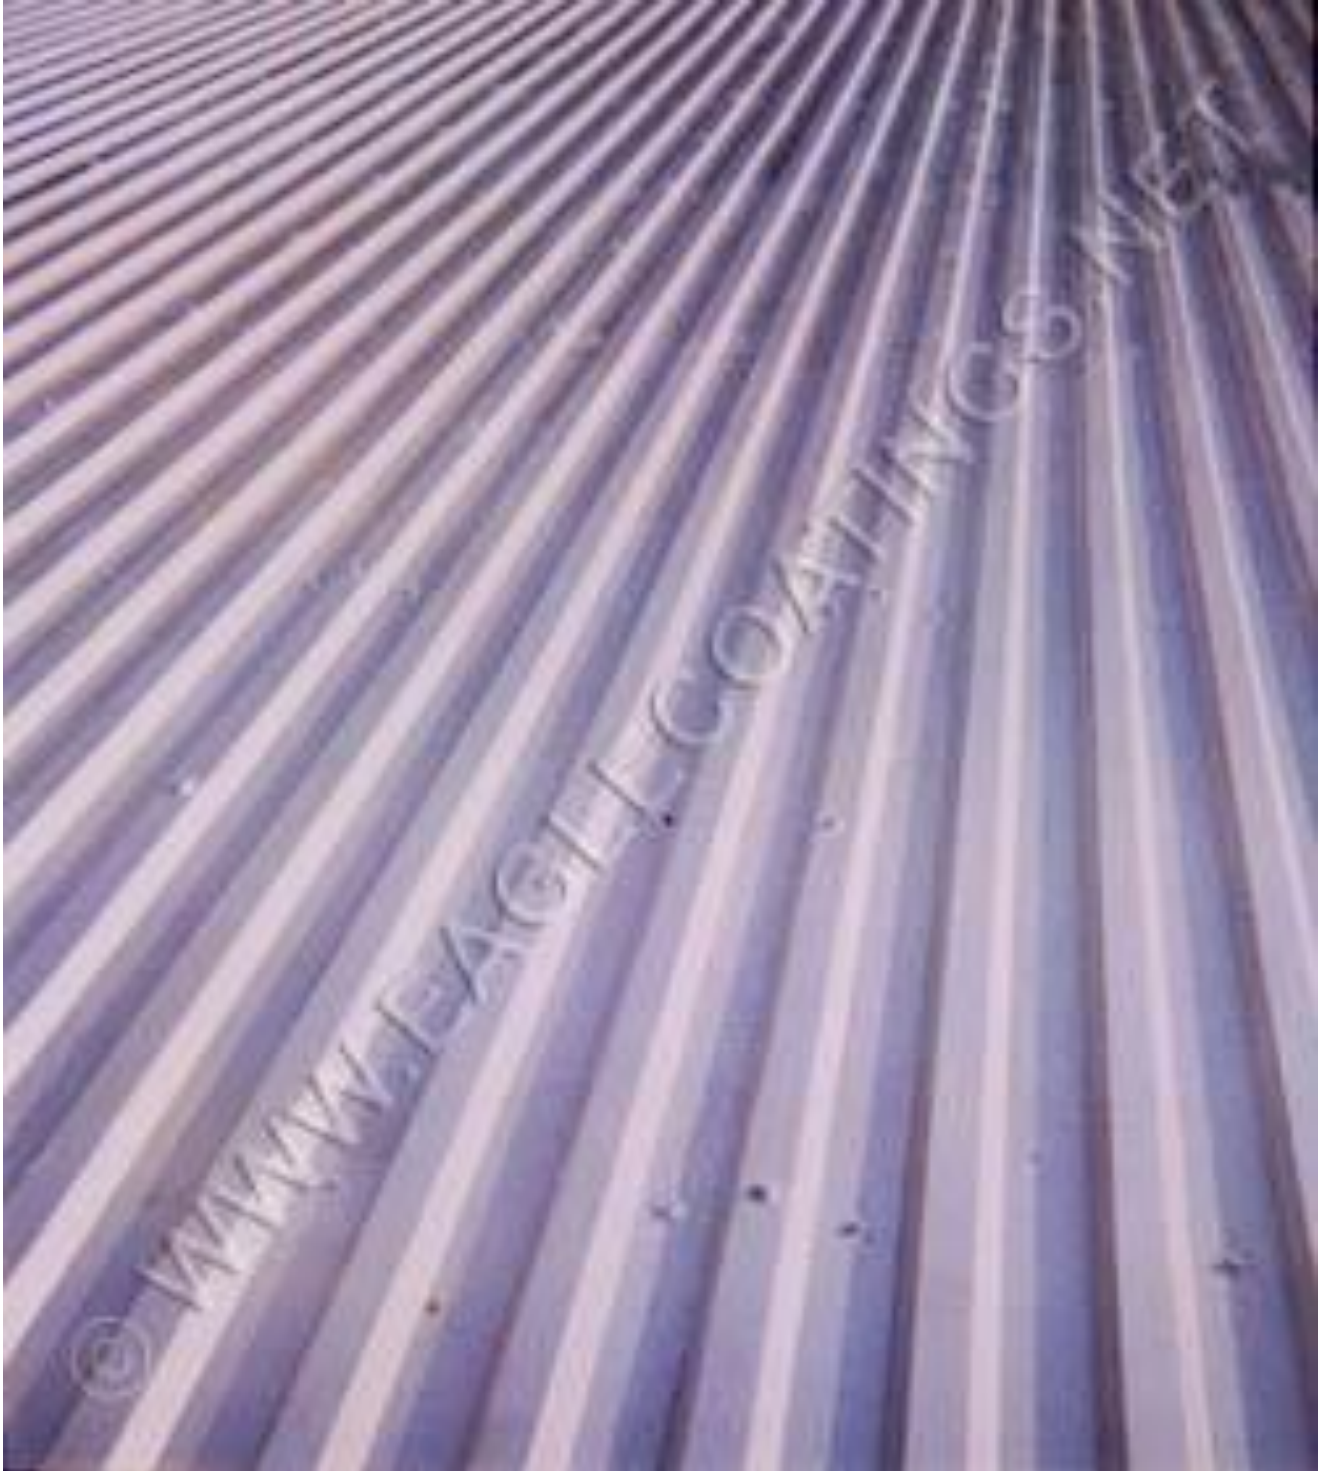
RUST GRIP® on metal roof panels

SUPERBASE (HS)® on seams and screws

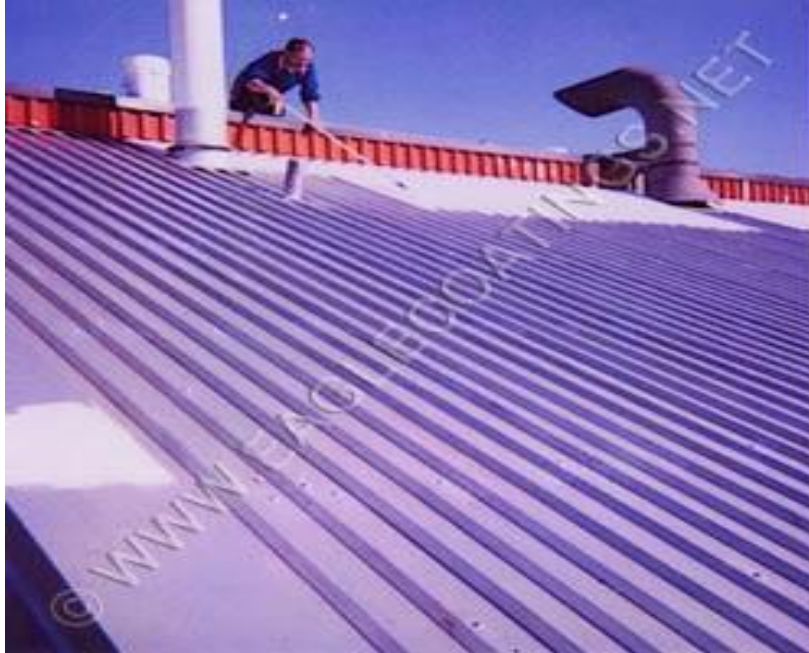
SUPERTHERM® 1ST COAT

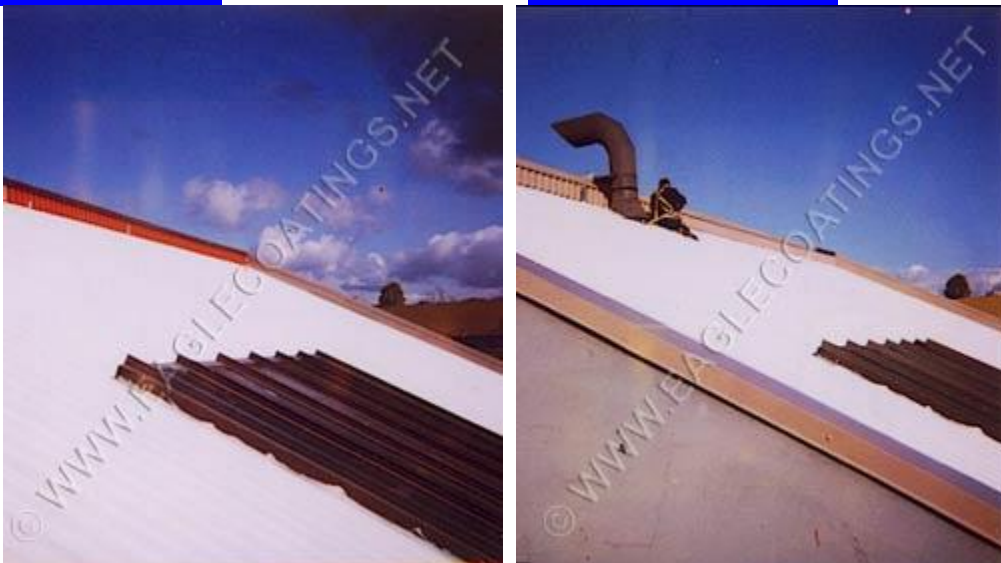
SUPERTHERM® 2ND COAT **ENAMO GRIP®** TOP COAT

ENAMO GRIP® ON FLASHING
