OFFICE ROOF

July 2012
Roof Maintenance

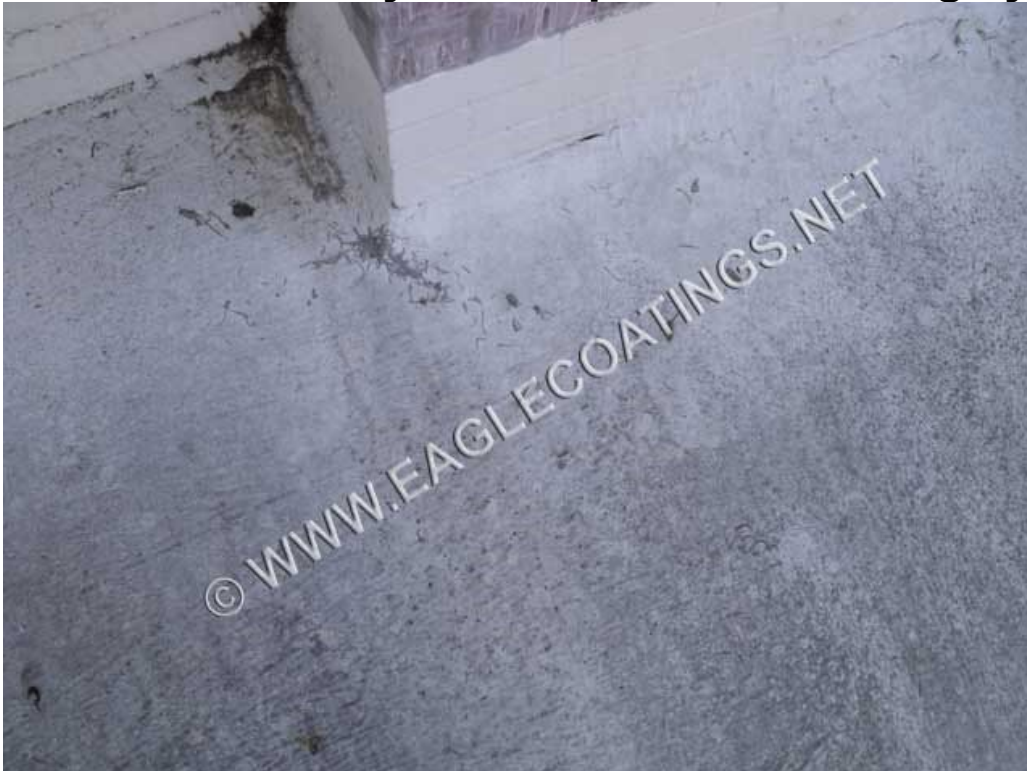
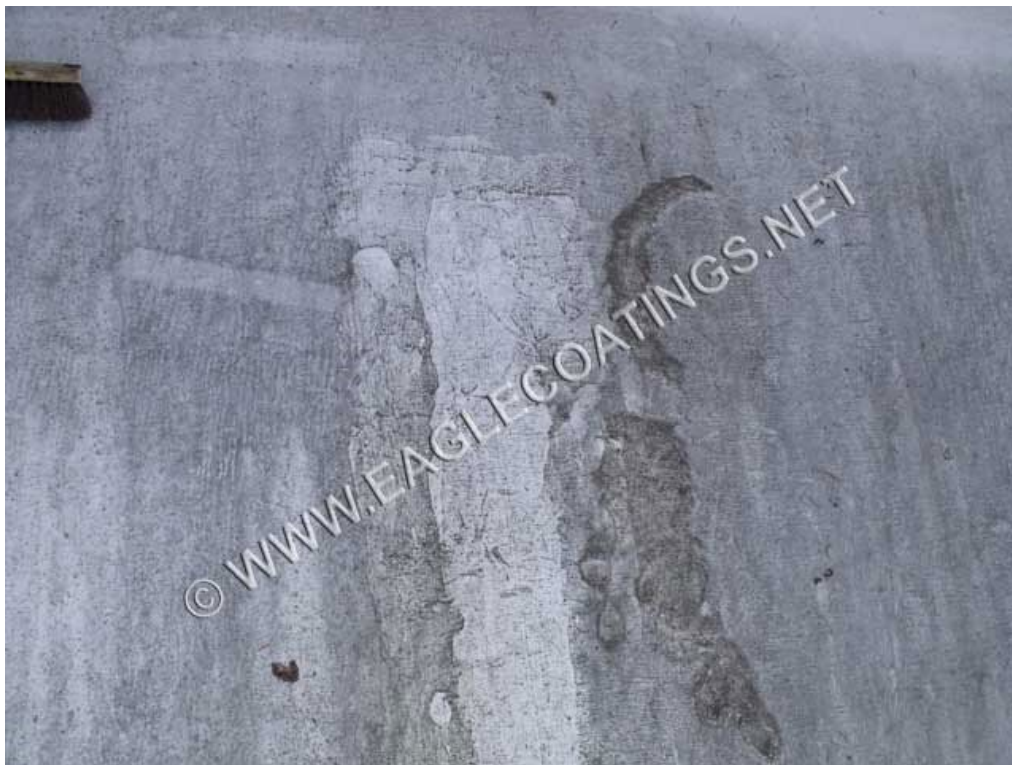
Existing coating was applied in 2007 10 Mils
DFT **SUPERTHERM**® over HLM 5000 no maintenance has
been performed since.
(no clean up of debris on the roof)

First we cleaned the surface of the roof to a clean, dry and
sound condition ready to accept a new coating system.
