## **BUNGE MEAL AND STORAGE**

**2nd St. North West, Altona, Manitoba  
July 17 2014**

The Problem: Insulate canola extractor and assist in regulating plant environment. Bunge Meal and Storage required an approximate 10,000 sq foot canola extractor to be insulated with **HSC® Coating** to a thickness of **100 mils [2.54 millimetres, 1/10th inch] DFT** to bring temperatures from **150°F** down to **100°F**.

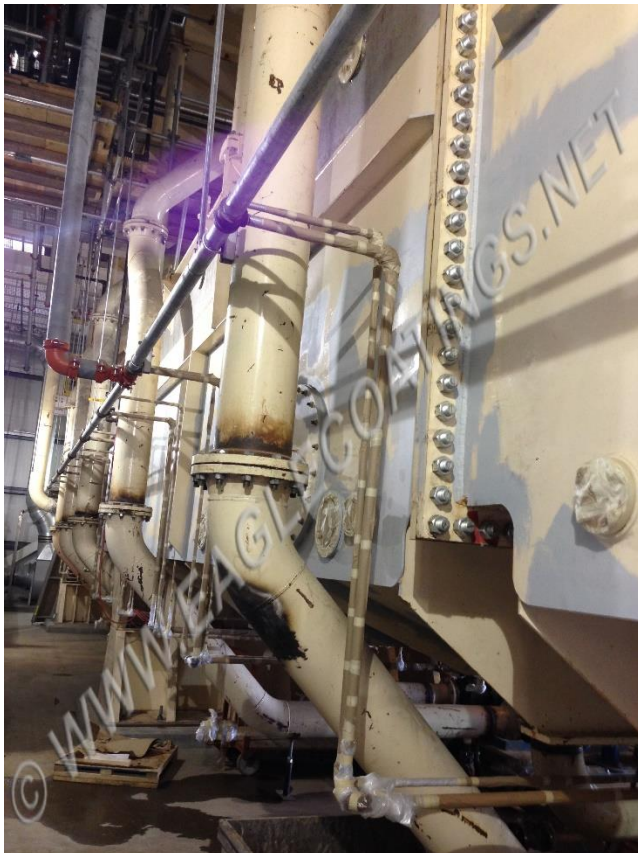
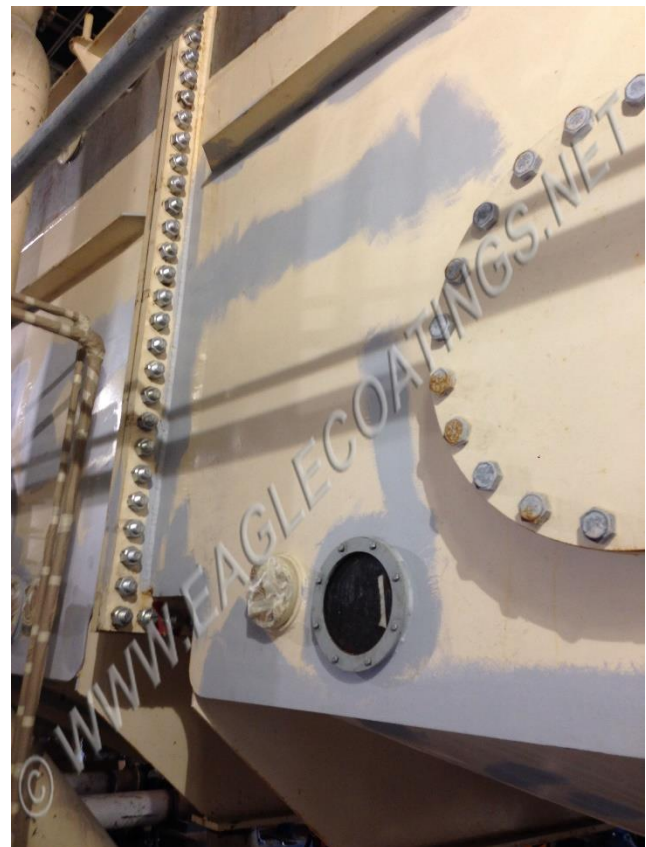
**Canola extractor prep before **HSC®** application**

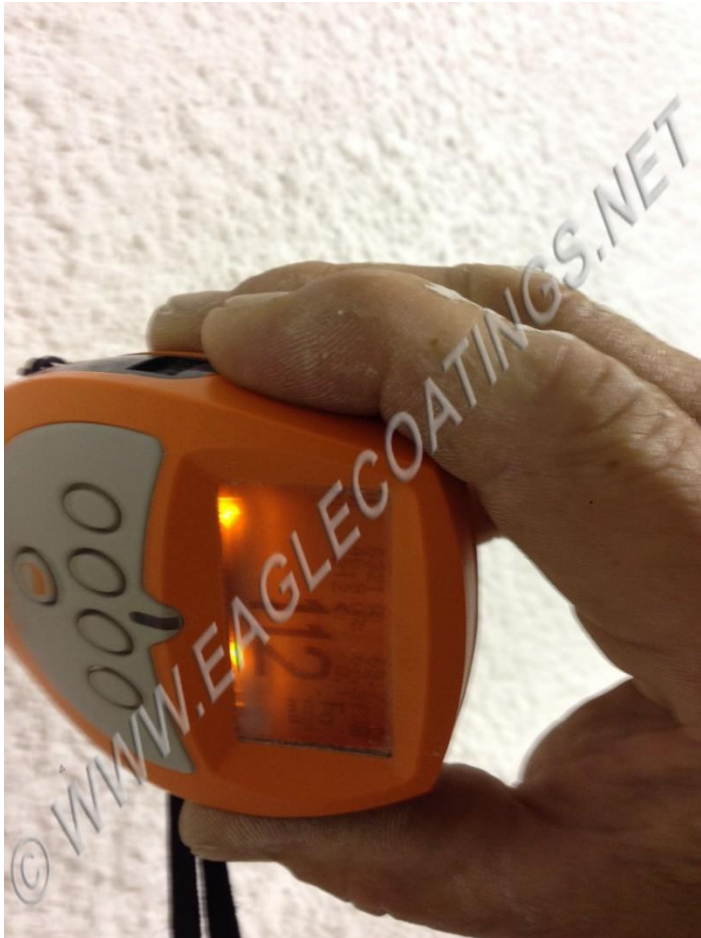
**HSC ® applied to 112 mils DFTTop coat of SUPERTHERM ®  
(applied at 9.8 mils DFT)**

After **HSC® Coating** was applied, a top coat of **SUPERTHERM®** was applied at a thickness of **9.8 mils DFT [0.25 millimetres, 0.0098 inches]** to protect from water washing during maintenance of the extractor.
